VIBRATION MONITORING OF GEARBOXES

Written By
James C. Robinson,
Technical Consultant, IMI division of PCB Piezotronics

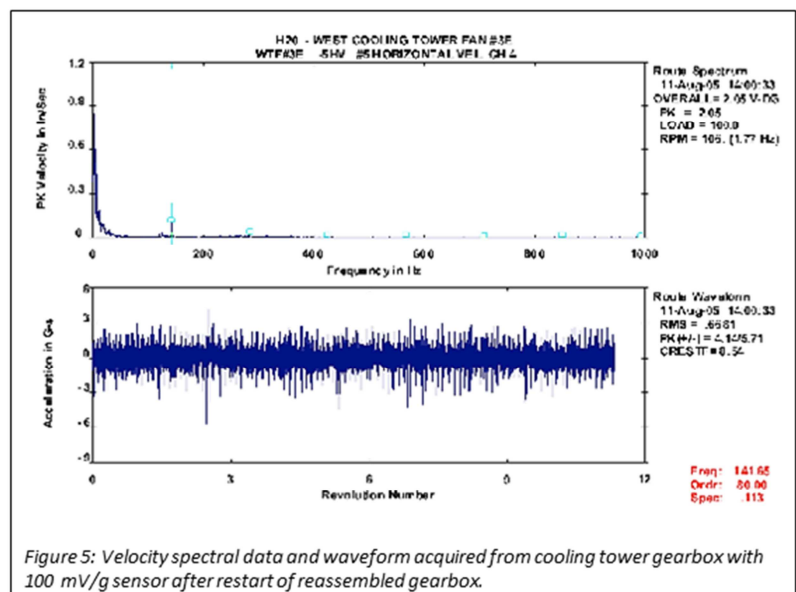
acquired and is presented in Figure 5. The peak-to-peak g-level is less than 10 g's, and the spectral data is a "ski slope". This is typical for an ICP® accelerometer that is being overloaded. The sensor was a 100 mV/g accelerometer with a 9-11 VDC bias voltage.

The accelerometer was replaced with a 10 mV/g accelerometer with a similar bias voltage. Using the 10 mV/g sensor, a 40 kHz acceleration spectra data set with waveform was captured and is presented as Figure 6. The peak-to-peak g-level was close to 200 g's, explaining why the 100 mV/g sensor's output was unstable. The primary cause of the high g-levels was friction occurring within the bearings as well as between the gear teeth as a result of an inoperable lubrication system driven by a gear oil pump.

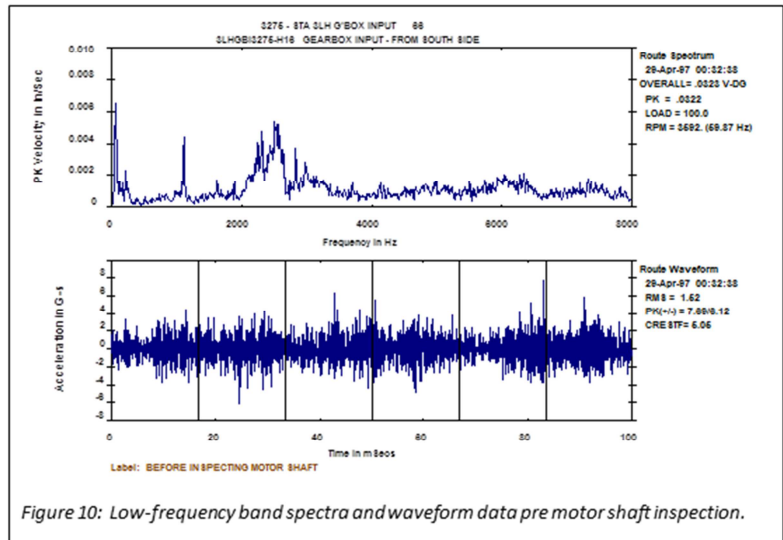
The low-frequency band spectra and waveform data are presented in Figure 10. The peak-to-peak g-level in the waveform data is about 14 g's. There is definite periodic activity around 1,000 Hz. There are probably two individual gear mesh frequencies in the expected frequency range of 2,100 to 2,300 Hz. Additionally, there is a broad band of spectra activity in the 2,500 to 2,800 Hz frequency range. The high-frequency (5 to 40 kHz) rectified waveform and spectra data taken at the same time as the low-frequency band data are presented in Figure 11. The spectra bandwidth of the high-frequency data in Figure 11 was specified at 1,000 Hz, which was an oversight. It should be slightly greater than twice gear mesh frequency (5 kHz). The peak g-level in the rectified waveform is about 8 g's. The bothersome feature of concern in the high-frequency spectra data in Figure 11 is the activity at slightly greater than 0.5 times running speed. It is an indication of a possible torsional resonance. Based on this observation, it was decided to inspect the motor shaft/key. A picture of the motor shaft/key is presented in Figure 12. There

Figure 10: Low-frequency band spectra and waveform data pre motor shaft inspection.

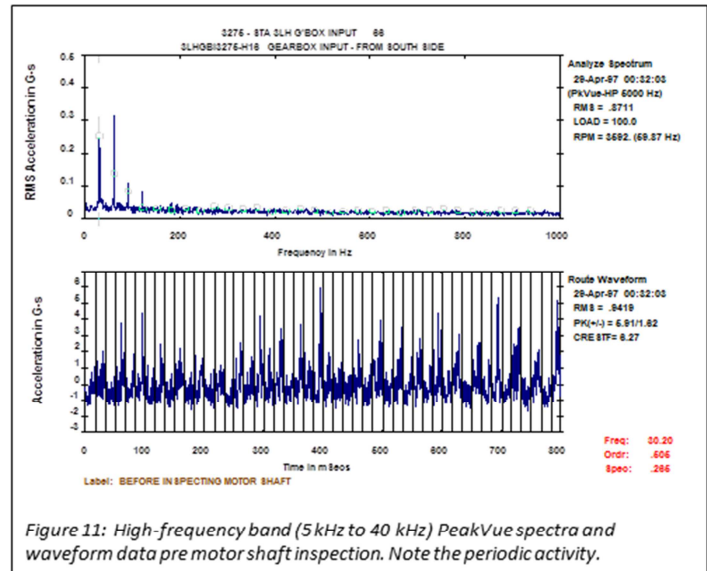
Figure 11: High-frequency band (5 kHz to 40 kHz) PeakVue spectra and waveform data pre motor shaft inspection. Note the periodic activity.

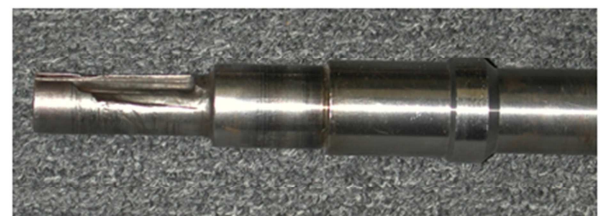
Figure 12: Picture of shaft from motor showing the shaft keyway wear.

has been considerable wear in the motor shaft keyway. The recommended solution was to decrease the tolerances in the keyway fit to the shaft. This corrected the shaft/key wear problem.

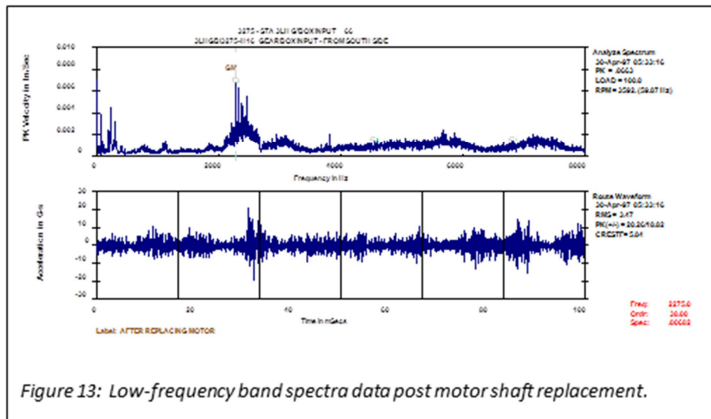
Spectra data taken after the motor shaft replacement is presented in Figures 13 and 14. The resolution is sufficient to clearly show the gear mesh frequency at 2,275 Hz as well as a probable torsional resonance at a frequency slightly greater than gear mesh frequency. The periodic activity that was seen in the high-frequency rectified waveform data before motor shaft change is gone. Additionally, the periodic activity that was seen at about 1,000 Hz in low-frequency spectra data before motor shaft change is also now absent. The most obvious change between the two sets of data is the significant increase in the vibration waveform amplitude. The peak-to-peak waveform in the low-frequency data went from 14 g's peak-to-peak to 40 g's peak-to-peak. A similar change occurred in the high-frequency rectified waveform. This is probably because the torsional stiffness increased with the tightening of the system at the motor shaft/key thereby increasing the torsional resonance frequency. The increase in vibration is more desirable than the shaft/key interaction.

Figure 13: Low-frequency band spectra data post motor shaft replacement.

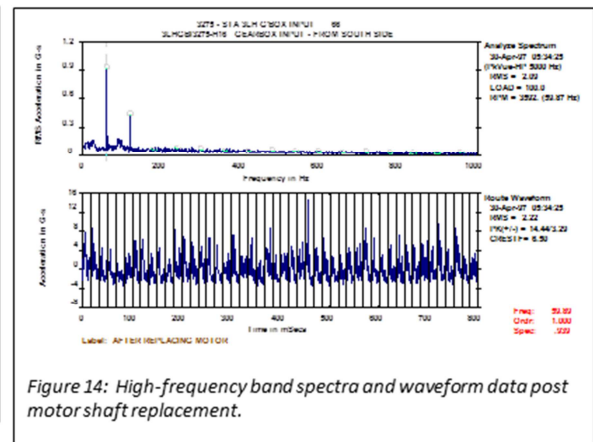
Figure 14: High-frequency band spectra and waveform data post motor shaft replacement.

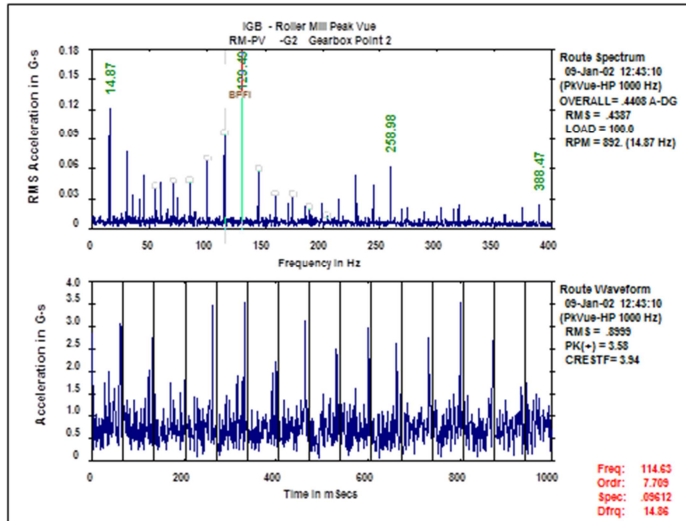
Routine monthly vibration data was acquired from all the measurements points on the gearbox. The high-frequency spectra data and rectified waveform from measurement point #2 are presented in Figure 16. The high-frequency band is from 1 kHz to 40 kHz. The 1 kHz is well above 2.25 times gear mesh frequency. (Gear mesh frequency is 330 Hz, which equals running speed of motor [15 Hz] times the number of teeth [22]). The bearing has an inner race fault in the early stages of failure based on relatively low peak g-level of 3.6 g's. The measurement was repeated approximately one month later and results are presented in Figure 17. The big difference in Figures 16 and 17 is the peak g-level has increased from 3.6 g's to 51 g's, which is significant. This bearing, based on high g-level of 51 g's, requires frequent monitoring with a replacement plan set in motion.

Figure 16: High-frequency, band-rectified waveform and spectra data taken on measurement point 2. Maximum peak g-level in waveform data is 3.6 g's.

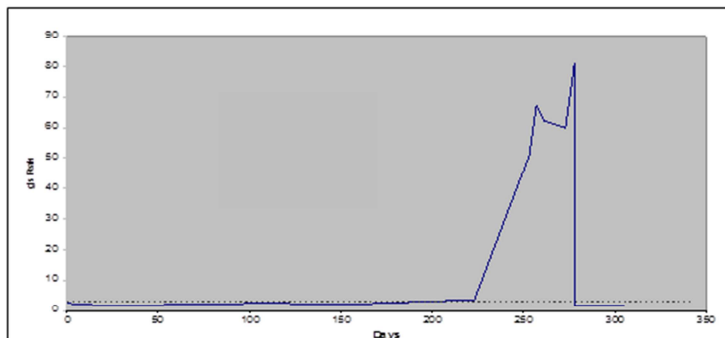
Figure 18: Peak g-level trend over an approximate 300-day monitoring period on measurement point #2.

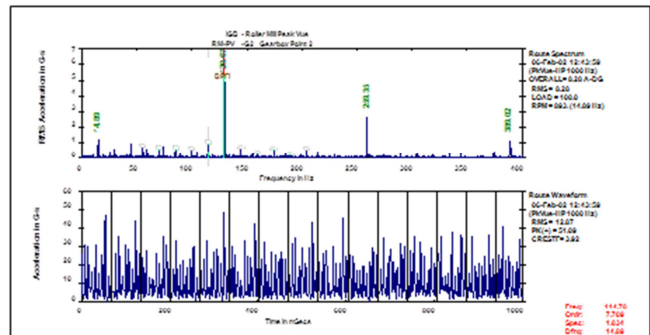
To assure the faulty bearing was bearing #3 and not bearing #1 or bearing #2, data was acquired from measurement point #1 at same time as the data in Figure 17 was acquired. The peak g-level in the high-frequency data from measurement point #1 was 25 g's versus the 54 g's from measurement point #2. The defective bearing was concluded to be bearing #3. Frequent monitoring with the sensor set on measurement point #2 was then carried out. The peak g-level trend is presented in Figure 18. From the time the 50 g peak level was detected, it took about 25 days to get the bearing replaced. A picture of the defective bearing is presented in Figure 19. The peak g-level recorded was about 80 g's.

Figure 17: High-frequency, band-rectified waveform and spectra data taken on measurement point 2 one month after the data taken and presented in Figure 16. The peak g-level in waveform data is 51 g's.

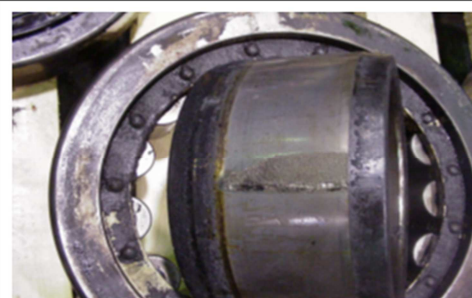
Figure 19: Picture of the defective bearing showing inner race fault. This fault could have been introduced from bearing being stored in vertical position too long. Notice metal removal on inner race downstream of fault suggesting the rolling element was penetrating the oil film when jumping over the crack.

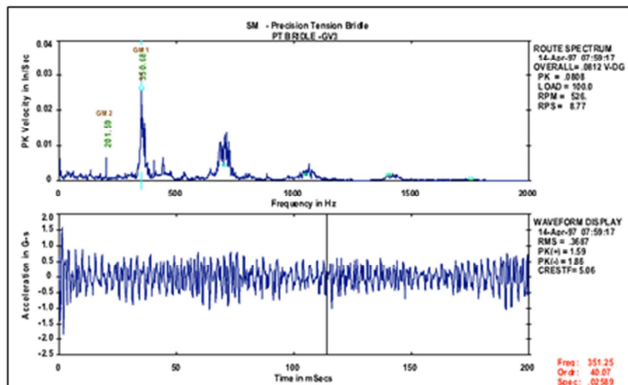
Figure 21: Low-frequency band spectra and waveform data taken from input shaft bearing housing. The most activity is from first and second harmonic of the input gear mesh frequency.

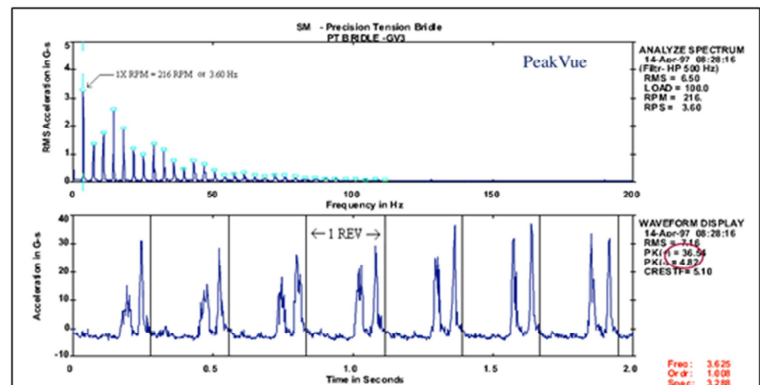
The spectra data indicates a significant event is occurring once per output shaft revolution. The waveform clearly demonstrates there are two distinct impulses per turn that could mean there are two cracks on one gear. When inspected, two cracked teeth on one gear were found.

Figure 22: High-frequency band from 0.5 to 40kHz rectified waveform and spectra data. The '1 REV' is for the slow dual shafts output. The spikes occurring once per revolution imply one of the 90 tooth gears has two cracked teeth.

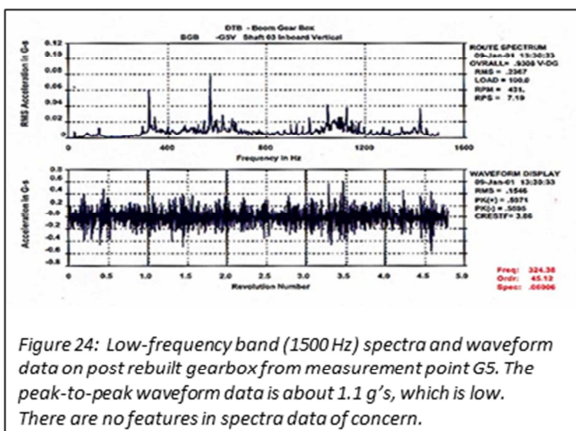
Figure 24: Low-frequency band (1500 Hz) spectra and waveform data on post rebuilt gearbox from measurement point G5. The peak-to-peak waveform data is about 1.1 g's, which is low. There are no features in spectra data of concern.

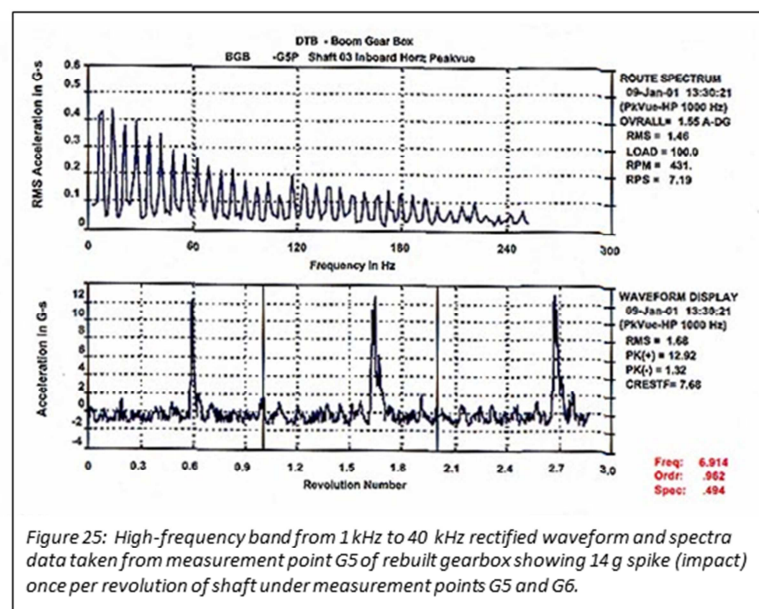
Figure 25: High-frequency band from 1 kHz to 40 kHz rectified waveform and spectra data taken from measurement point G5 of rebuilt gearbox showing 14 g spike (impact) once per revolution of shaft under measurement points G5 and G6.

The waveform and spectra data for the low-frequency band are presented in Figure 24. The peak-to-peak g-level in the waveform data is about 1.1g's, which is not considered to be indicative of a problem. The high-frequency band rectified waveform and spectra data are presented in Figure 25. There is a spike (about 14 g's) occurring once per revolution of the shaft immediately below measurement points G5 and G6. This is the expected signature from a cracked tooth in the gear immediately below measurement point G5. Upon inspection of this gear, it was found to have a crack in the root.

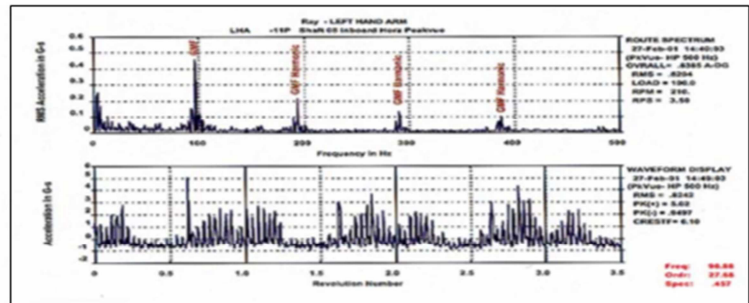
A gearbox was removed from service and sent to the shop for rebuild. Upon completion of the rebuild, the gearbox was subjected to low and high-frequency vibration analysis. The low-frequency measurement showed no sign of a problem. The high-frequency band (from 0.5 to 40 kHz) rectified waveform and spectra data are shown in Figure 26. The high-frequency (0.5 to 40 kHz) rectified waveform is showing a definite repeating pattern of increased activity over approximately 65% of a single revolution

and low amplitude activity over the remaining 35% of the revolution. This is the pattern expected for an eccentric gear. In the spectra data, there is significant activity at gear mesh frequency, which is indicative of a stable rotational speed of the gear. Following replacement of the eccentric gear, the high-frequency rectified waveform and spectra were acquired and are presented in

Figure 26: High-frequency band rectified waveform and spectra data from a completed rebuilt gearbox.

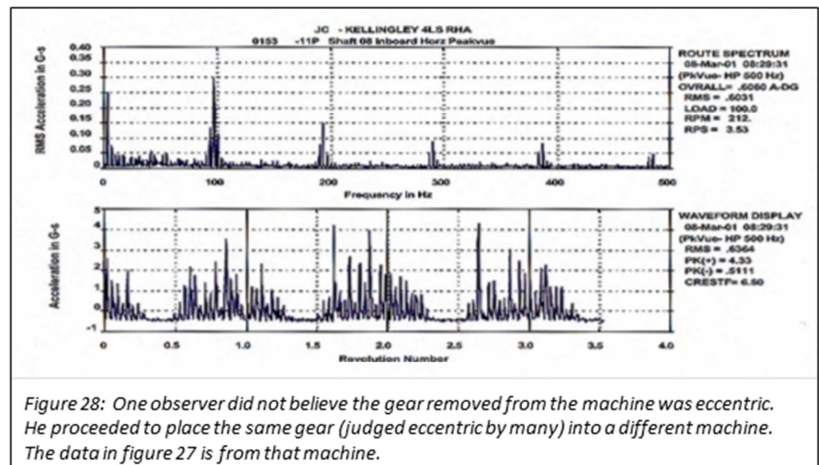
Figure 27. Someone was not convinced the gear was eccentric and placed the defective gear in another gearbox. When it was subjected to testing, the results presented in Figure 28 were obtained which was basically the same as that presented in Figure 26.

Figure 28: One observer did not believe the gear removed from the machine was eccentric. He proceeded to place the same gear (judged eccentric by many) into a different machine. The data in figure 27 is from that machine.

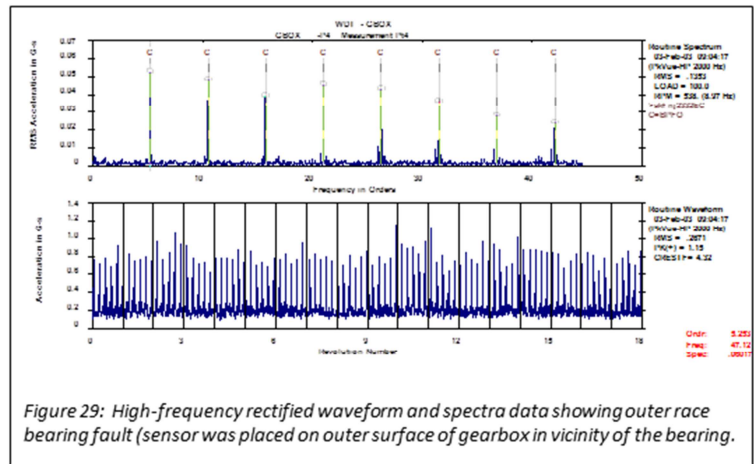
The rectified high-frequency band (2-40 kHz) waveform and spectra data are presented in Figure 29 from a sensor mounted over the outboard spur section of the gearbox. The spectra data is dominated by activity at 5.253 orders with many harmonics. This is the outer race fault frequency for the bearing used on the outboard end of the intermediate shaft in the spur gear section. The observed peak g-level of 1.15 g's for this speed shaft (538 RPM) is very low. The recommended alert level is 4-5 g's. This fault could very well be from the early stage fatiguing with cracking occurring under the outer race surface. The fault may not be visible if examined at this time by sight or by feel. Typically, wait until peak g-level reaches 6-8 g's (for this speed machine) before a plan is put in place for changing out the bearing unless there are special circumstances such as it is most economical to implement the change at this time.

Figure 29: High-frequency rectified waveform and spectra data showing outer race bearing fault (sensor was placed on outer surface of gearbox in vicinity of the bearing).

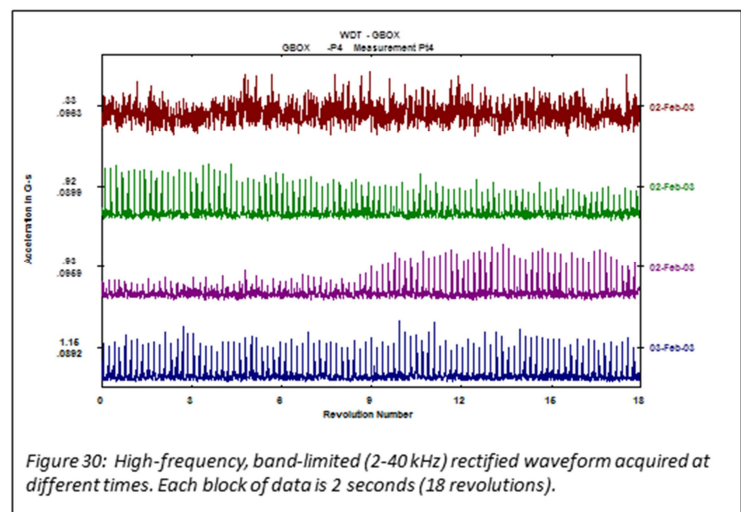
Figure 30: High-frequency, band-limited (2-40 kHz) rectified waveform acquired at different times. Each block of data is 2 seconds (18 revolutions).

The data in Figure 30 was chosen to illustrate how the fault signature can vary over reasonably short times. Each rectified time waveform is for a period encompassing 18 revolutions (2 seconds) of the intermediate shaft turning at 538 rpm. The last trace of data in Figure 30 is the same set of rectified waveform data presented in Figure 29. The three remaining data traces were acquired one day previous.

There is very little fault signature showing up in the first rectified waveform data. In the middle two traces of rectified waveform data, a fault signature is present but with considerable variability. If the signature was a result of impacting from a defect in the inner surface of the outer race, the rectified time waveform would not be expected to have the variability seen in Figure 29.
