Creating an Effective Vibration Monitoring Program for Reliability Departments With Limited Resources

Two Parameter Predictive Maintenance Program

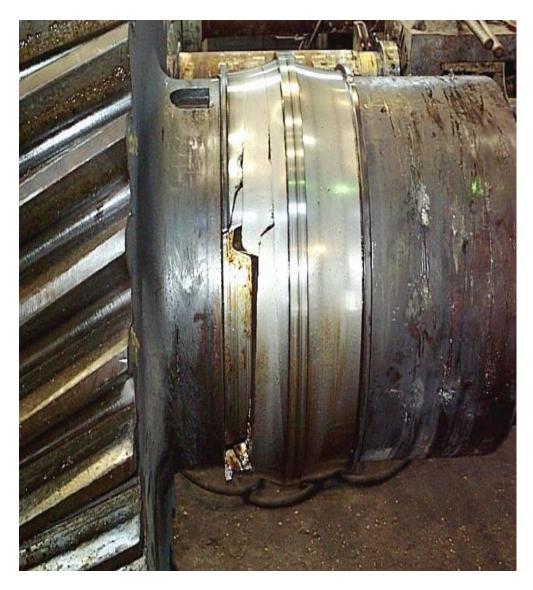
The spectral data in Figure 3 identifies the fault as an inner race fault. The low frequency RMS velocity was also trended over the same time. It remained reasonable constant fluctuating around 0.03 ips for the entire 800 days of observation. The bearing's inner race (Fig. 4) as found to be severely cracked and replaced. The trend parameters returned to their original low levels following bearing replacement.

Figure 4 Picture of defective bearing from the hot mill pinion stand gearbox

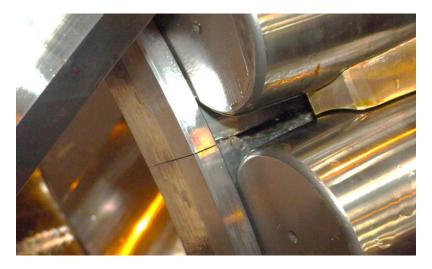
Figure 6 Picture of the bearing with cracked inner race from the press suction roll

The third case is a cracked inner race on a press suction roll in a paper machine running at 220 RPM. For this speed machine, the alert level recommended in Figure 1 is 2 g's. The peak acceleration spectra and time waveform acquired on June 5, 2003 are presented in Figure 5. The peak acceleration of 14 g's is significantly greater than the recommended alert level of 2 g's. A picture of the cracked inner race is presented in figure 6 showing significant damage had occurred.

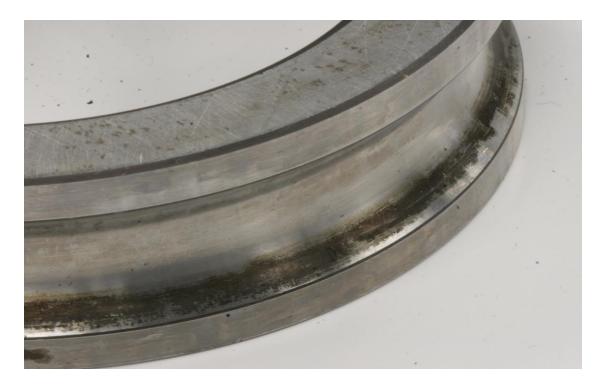
Figure 11 A picture of the inner race of the bearing removed from the centrifugal pump

The RMS velocity trend parameter did not change very much from before until after the bearing change out on January 15, 2013(Fig. 9). In contrast, the True Peak Acceleration went from a peak of 27 g's prior to bearing change to a quiet 1 g following bearing change out. The fault chart in Figure 1 suggest that an alert level for this speed machinery should be set at 5 g's which is well above the 3 g level in Figure 10 following the bearing change out. A picture of the inner race from the defective bearing is presented in Figure 11.

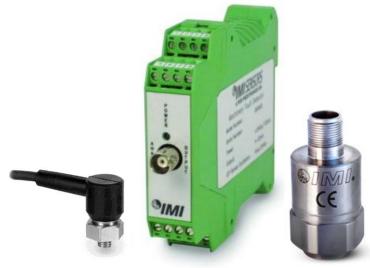
IMI Models 607A11, 682B05, and 649A03

IMI Sensors also offers the Bearing Fault Detector Plus (model 649A03), which combines filtered transmitter electronics and accelerometer into one small package. This unit can be mounted directly to the bearing housing and connected to a PLC or DCS. Although it can only output one measurement at a time, this unit has 5 measurement options: RMS acceleration, True Peak acceleration, Compensated Peak acceleration (using bearing diameter and speed to normalize output), Crest Factor, and Crest factor Plus (based on original combination of the peak, RMS, and crest factor) for improved detection on variable speed machinery. Similar to model 682B05, model 649A03 has an over RMS acceleration output (high pass filtered at 2500 Hz) and True Peak acceleration output (high pass filtered at 250 Hz.)

Executing the two-parameter approach does not require a highly skilled vibration analyst team or current advanced equipment employed in the walk-around predictive maintenance program. This method does require a permanently mounted accelerometer at each monitoring point. IMI carries an extensive inventory of low cost industrial accelerometers (603,607 and 608 series). Once the sensors are mounted, there must be a way to forward the status of each to appropriate staff. IMI Sensors offers a 4-20 mA Transmitter (682B05) specifically designed for Bearing Fault Detection. This unit can be connected to any standard ICP® accelerometer and provides both an overall RMS velocity and True Peak acceleration signal for communication with a PLC or DCS. Its RMS measurement covers the low frequency band at 10-1000 Hz, and its True Peak measurement covers the high frequency bandy at 1 or 5-100 kHz (depending on internal settings.) The 682C05 Bearing Fault Detector also has a third output for the raw acceleration signal, which is useful for detailed diagnostics with a data collector.

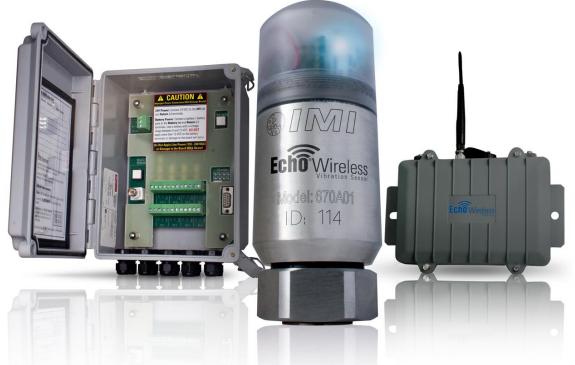
Echo® Wireless Vibration System

Finally, the parameters could be sent back via the IMI Echo® Wireless Vibration Monitoring System. The strength in Echo® lies in the transmission range you can have between the sensor and the receiver. It can transfer vibration measurements across a distance of 2500' to ½ mile in typical industrial environments. This narrow bandwidth system allows for vibration monitoring of hundreds of points across an entire plane; however, it has limited data transfer rate. Therefore it is not practical to send the raw vibration waveform data back using Echo®, but the periodic filtered measurements work perfectly with the two parameter method.
