**TN-34**

# **Cause of and Solution for Cable Generated Noise in Accelerometer Signals**

# CAUSE OF AND SOLUTION FOR CABLE GENERATED NOISE IN ACCELEROMETER SIGNALS

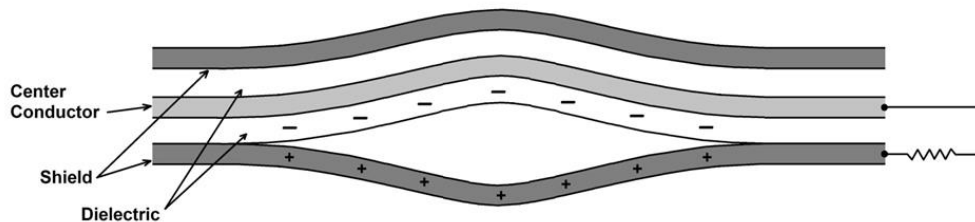
Figure 1. Charge Generation within a Coaxial Cable

Examining Figure 1, during cable vibration charge builds up due to relative motion between the shield (in this case positive) and the dielectric (in this case negative) due to rubbing. The shield and dielectric separate, and the mobile charge on the shield flows into the charge sensing amplifier resulting in additive noise superposed on the

acceleration signal. Under continuing cable vibration different portions of the shield and dielectric open and close and triboelectric induced noise effects become an ongoing, additive contribution to the signal. One contributory solution is to pack all the internal cable interfaces with graphite, which essentially functions as a conductive shunt when the cable materials separate, thus eliminating charge buildup. Figure 2 shows such a graphite lubricant between the dielectric and the shield to minimize triboelectric effects.

**TRIBOELECTRIC EFFECTS IN PIEZOELECTRIC ACCELEROMETER SIGNALS:** Signal generation within a cable (as opposed to cable pickup) attributable to triboelectric effect has long been known to occur in the output from piezoelectric sensors (force, pressure, acceleration transducers) operating in a charge mode (i.e., without contained electronics (non ICP® or non IEPE)). For this effect to occur there must be cable motion. Since all instrumentation cables are combinations of metal conductors, inner dielectrics, metal shields, and outer jackets of differing materials, it would be expected that any motion of the cable would result in some triboelectric effect (signal generation). As it is associated with piezoelectric accelerometers this motion has traditionally been attributed to cable vibration. Figure 1 shows one example of this charge generation within a coaxial cable.

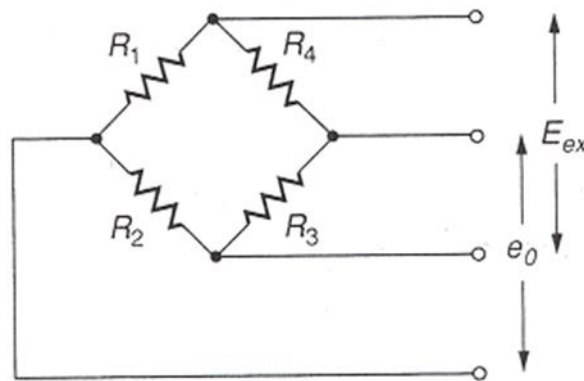
Figure 3. Electrical Model of MEMS Sensing Element

The aerospace industry was the first to recognize the potential destructive effect of pyroshock. The firing of explosive bolts, nuts, pins, cutters, and other similar devices initiated this pyroshock. Subsequently, it was recognized that other environments (e.g., the sudden release of strain energy and metal-to-metal impact), although not initiated by explosive devices, produced effects similar to pyroshock. Because the stimuli that initiate pyroshock are applied instantaneously, the structure's net velocity change is zero. Pyroshock measurements are attempted with both mechanically isolated piezoelectric accelerometer and MEMS accelerometers<sup>2</sup>. The electrical equivalent of a thermally uncompensated MEMS accelerometer is shown in Figure 3 and obviously requires a 4-wire shielded cable (e.g., Figure 4) as opposed to the coaxial cable associate with the charge mode accelerometer.

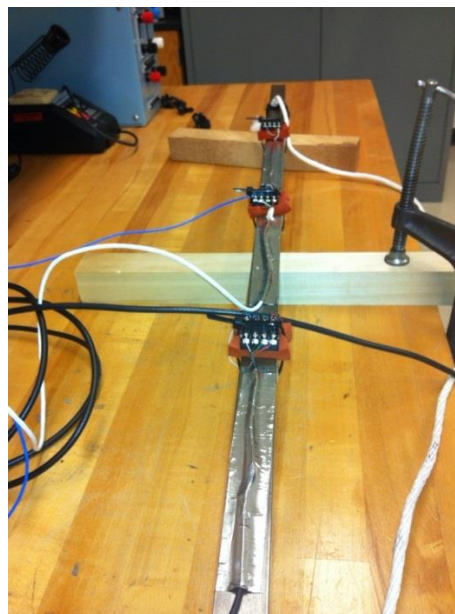
Figure 8: 1 inch by 1 inch Square Hopkinson Bar Used in Testing

**SOLUTION INVESTIGATION:** The solutions to cable noise attributable to triboelectric effects include, among others: (1) in vibratory environments minimize cable “whip”, (2) in severe mechanical impact environments avoid securing the cable to any structure in such a manner that stress waves couple into it (keep it as free as possible), and (3) use as much graphite as possible as a cable filler between cable constituents. Testing was performed to evaluate these solutions postulates. Figure 8 shows three cables affixed to a long, slender bar with aluminum tape. The cables were identically terminated in both 350 and 1000 ohm metal film resistor bridges that were mechanically isolated from the bar. During the course of testing various types of support tapes were used. Figure 8 shows only one of many test configurations in terms of cable routing. The test bed was a Hopkinson Bar with a 1 inch square cross section and a length/width ratio of 48:1 to assure essentially 1-dimensional wave motion. The bar was impacted numerous times on its end and cable triboelectric responses were monitored.

existing PCB Model 34 cable. Both accelerometers had their cables identically bonded to the 1 inch square 48 inch long Hopkinson bar. The accelerometers themselves were allowed to hang off the bar. With no power applied to either bridge, the results of Figure 9 were essentially replicated. This was as expected.

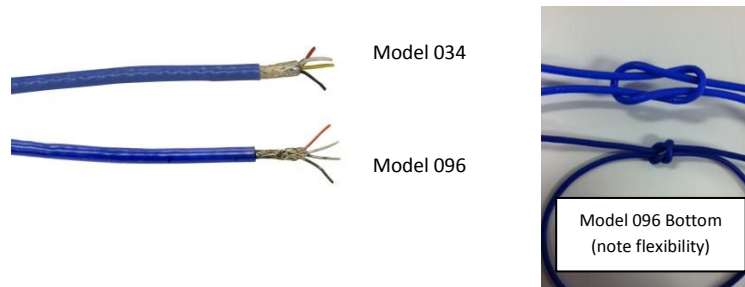
Figure 11: PCB MEMS Cable Model 034 Comparison to New Model 096 Stranded Wire Silicone Rubber Cable

This cable design change is being incorporated into all future PCB MEMS accelerometers intended for pyroshock applications (Figures 10 and Figure 11) reflecting continuous product improvement. In addition to these findings, results of this study indicate that for any accelerometer cable encountering pyroshock one should: (1) minimize cable contact points with the surface being impacted as much as possible and (2) use the minimum hold down surface area.
