# Causes of Zero Offset in Acceleration Data Acquired While Measuring Severe Shock

Anthony Agnello, PCB Piezotronics

## Abstract

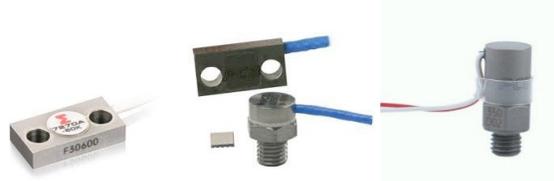
Figure 1. Physical Envelope of Pyroshock Accelerometers, left to right: 7270 A (form also standard for 3991 and 7280A), 3991/3501 with surface mount, 350DO2

The single-axis accelerometers from Endevco and PCB appropriate for pyroshock including near field are shown in Table 1 and Figure 1.

Endevco 7270A	60 KG	200mV FS	$f_n \sim 600$ KHz	1.5 grams
PCB 3991/3501	60 KG	200 mV FS	$f_n \sim 130$ KHz	1.5 grams
Endevco 7280A/AM4	60 KG	200 mV FS	$f_n \sim 130$ KHz	1.5 grams
PCB 350DO2	50 KG	5000 mV FS	$f_n$ suppressed	4.5 grams

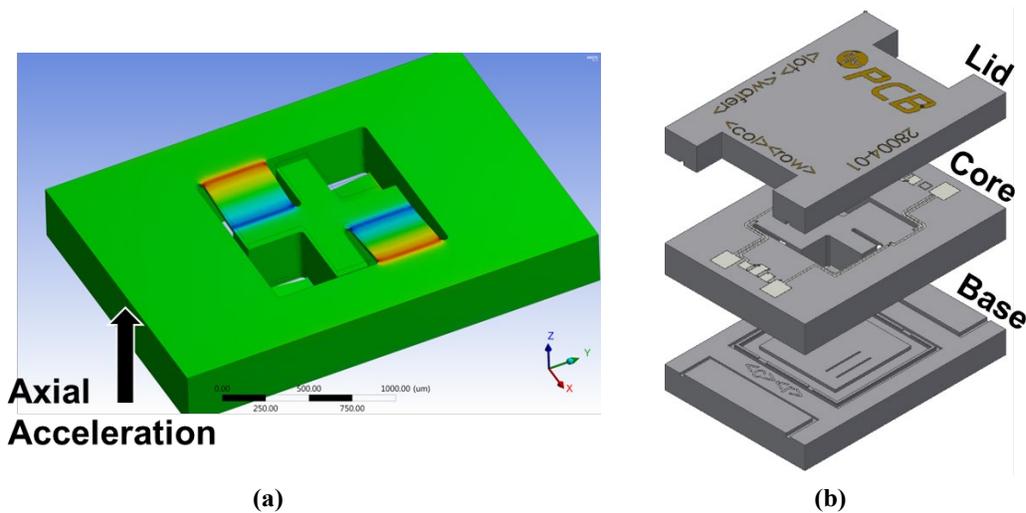
Figure 2. Piezoresistive MEMS element (a) and die package (b). Red color on the element indicates an area of high strain and good location for the implanted piezoresistive gage.

Zero shift in PR sensors is not inherent to the silicon structure itself (Figure 2a). Rather, it is the result of residual stresses transmitted through various interfaces in the sensor die and packaging (Figure 2b). Silicon is a crystalline linearly elastic material without hysteretic characteristics that might cause a non-return to zero. Piezoresistive gage areas are created by implanting dopants into the silicon resulting in a unitary crystalline structure. When subject to shock below its fracture strength, the silicon structure in isolation cannot permanently deform. However, PR accelerometers can zero shift when shock induced residual stresses are transmitted into the active gage area of the silicon sensing structure. These stresses originate at stressed interfaces such as die bond layers, die packaging, wiring, or at the sensor mounting interface. In designing a PR accelerometer for pyroshock, it is the goal to minimize transmission of residual stress into the active gage area of the silicon structure. Out-of-band high-frequency content and subsequent sensor resonant ringing is another potential source of zero offset resulting in bad data or even permanent damage to the sensor. A successful design strategy to eliminate this influence is a controlled gap between the moving sensing element and the core/lid. The controlled gap provides both viscous air damping and overrange stops that engage when the sensor is subject to shock beyond its specified range.

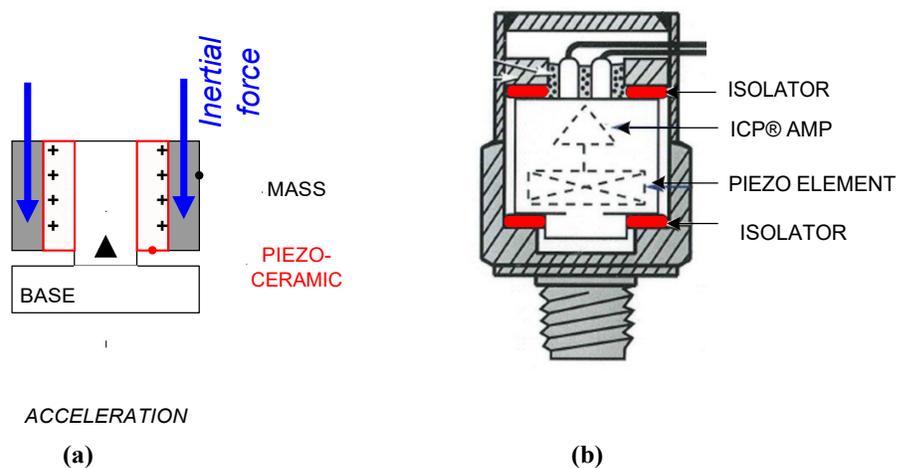
Figure 3. Piezoceramic element (a) and packaged sensor (b). Mechanical isolator isolates both the piezoceramic element and ICP® amplifier from out-of-band energy.

With PE accelerometers, dipole realignment is an additional source of zero-shift for certain piezoceramic materials [4]. A successful design strategy for PE accelerometers is the incorporation of a built-in mechanical isolator and use of special piezoceramics that do not exhibit the dipole switching phenomenon. The mechanical isolator serves two functions. It filters out of band high-frequency energy and reduces strain transmission into the piezoceramic element. The isolator must be designed to be linear over the sensor operating range so that isolator nonlinearity is not a cause of offset error.

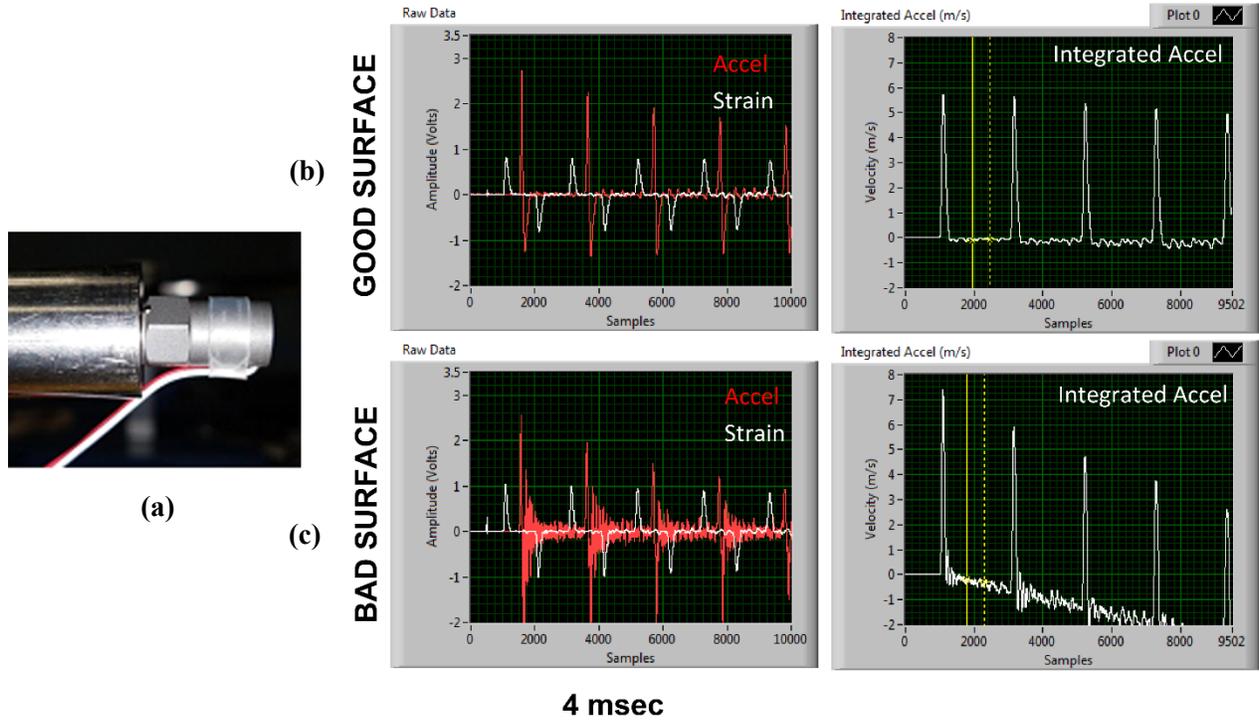
Figure 4. Shock at 25,000G peak with varying surface conditions. PCB Model 350D02 ICP® PE sensor on Hopkinson bar (a); integration to velocity with good mounting surface (b); and integration to velocity with 0.003-inch-thick debris on the mating surface at (c).

In the first example (Figure 4), an ICP® piezoelectric accelerometer (PCB Model 350D02, contains integral mechanical filter) is mounted to the end of the Hopkinson bar with a 0.003-inch-thick piece of flat solder underneath it, mimicking a surface imperfection such as a thread burr that might be found in field application. With a good mounting surface, the velocity is well behaved, returning to zero after each acceleration pulse (Figure 4b). With debris on the mounting surface, the velocity does not return to zero between impacts.

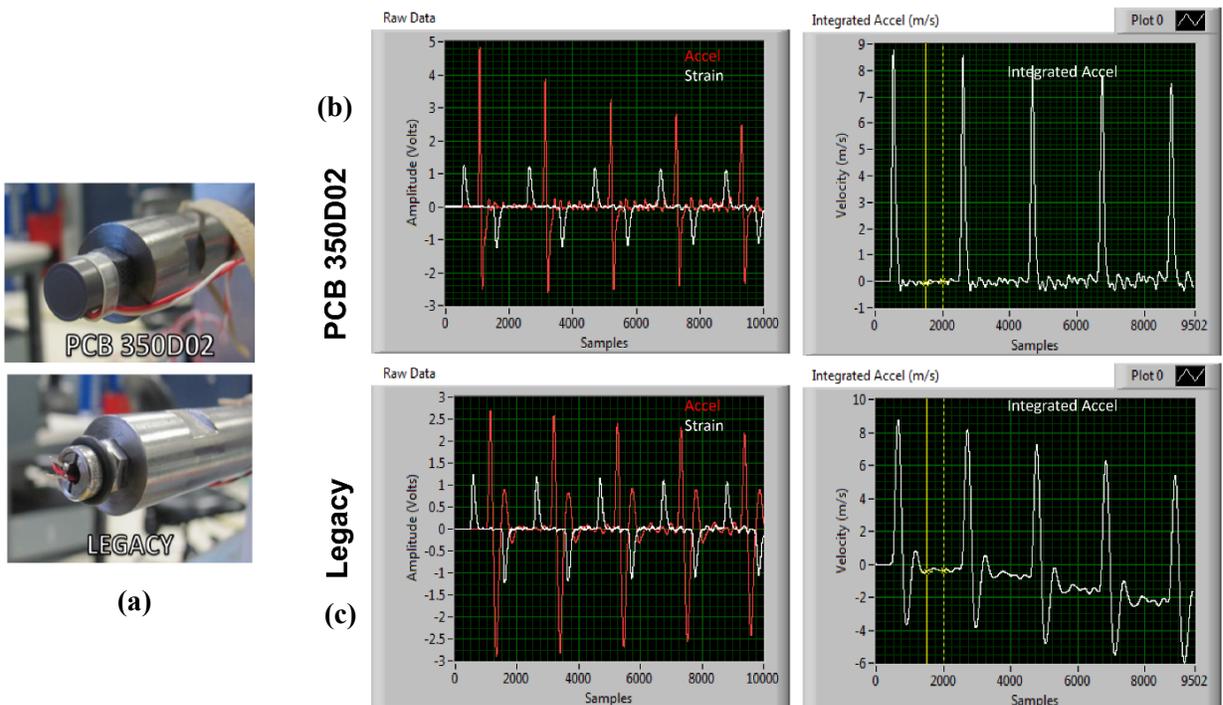
Figure 5. Shock at 50,000G peak with varying sensor models. PE sensor models with integrated mechanical isolators mounted on Hopkinson bar (a); integration to velocity of PCB Model 350D02 PE sensor (b); and integration to velocity of legacy PE sensor (c).

The second example demonstrates the importance of choosing a PE accelerometer with a well-designed mechanical isolator (Figure 5). The integral mechanical isolator must be linear over the full shock acceleration range and the isolator’s resonance must be well-beyond the frequency band of interest. In this demonstration, the PCB Model 350D02’s velocity properly returns to zero after each impact (Figure 5b). In contrast, the mechanical isolator in the legacy model is not properly designed for the shock environment, exhibiting non-linearity and in-band resonance resulting in zero offset (Figure 5c).

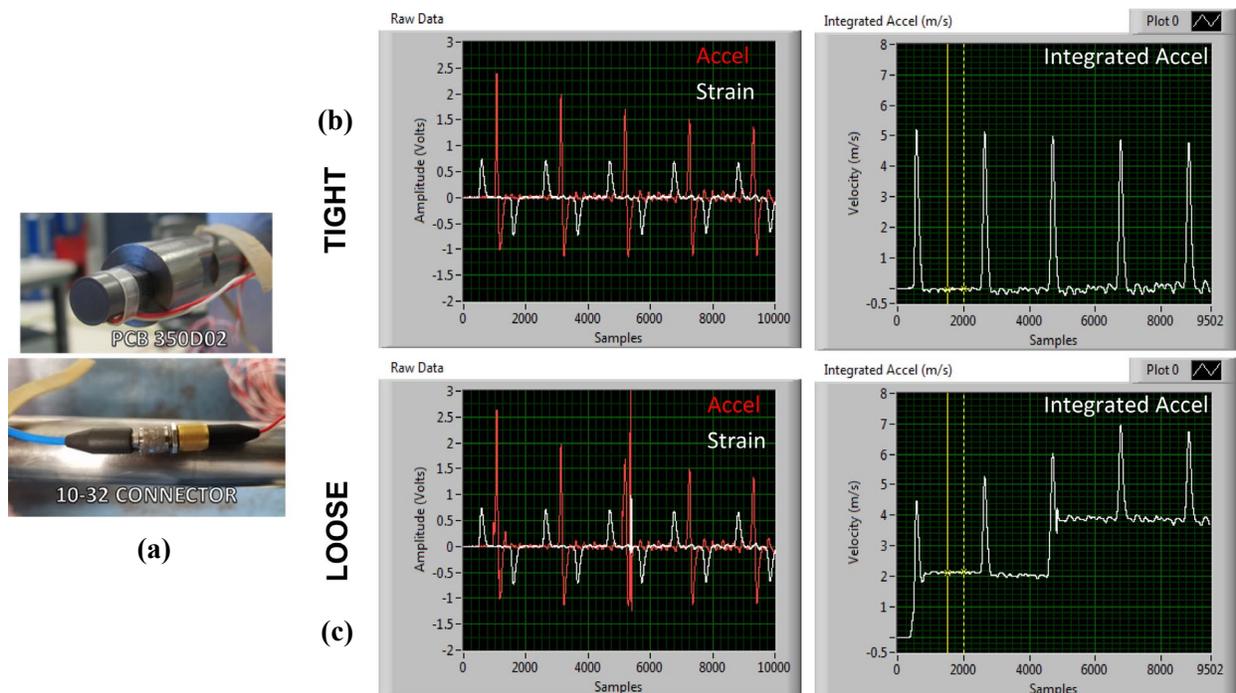
Figure 6. Shock at 28,000G peak with varying connection integrity. PCB Model 350D02 sensor mounted to end and cable/connector attached to the side of Hopkinson bar (a); integration to velocity with connector nuts tight (b); and integration to velocity with one of the nuts not fully engaged (c).

The third example demonstrates the importance of reliable cable connections (Figure 6). Arguably the cable connection is the weak link in the measuring chain and first suspect when bad data is obtained. In this example a 10-32 microdot connector connects the coaxial signal conditioner cable (blue) to the twin lead sensor cable (red and white). The connector assembly is tied down to the Hopkinson bar mimicking cable motion that might be encountered in the field during a shock event. With connector’s knurled nuts fully engaged the sensor does not exhibit zero offset (Figure 6b). When one of the nuts is not fully engaged there is movement between the connector pin and socket resulting in zero shift (Figure 6c). It should be noted that the poorly engaged connector only exhibits brief intermittency during the highest levels of shock. Under most conditions the sensor would test acceptably. Because of the intermittent nature, this is something that would be difficult to diagnose in the field.

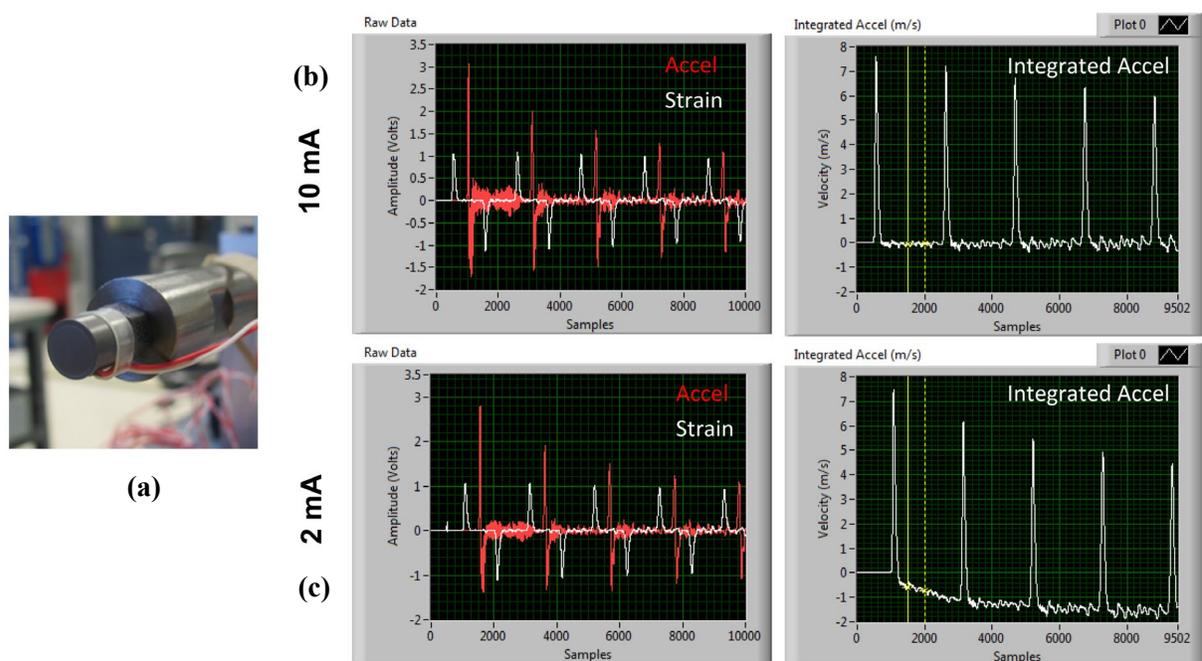
Figure 7. Shock at 60,000G peak with 130-foot long coaxial cable (4000 pF capacitance) and varying ICP® supply current. PCB Model 350B21 ICP® PE on Hopkinson bar (a); integration to velocity with 10 mA supply current (b); and integration to velocity with 2 mA supply current (c).

The fourth example demonstrates the importance of sufficient supply current when ICP® type sensors are used with long cables (Figure 7). Supply current sufficient to drive cable capacitance is required to avoid signal slew distortion [8]. To conserve battery life, most ICP® battery conditioners are set to 2 mA. Of the data acquisition systems that have integral ICP® signal conditioning, many have supply current limited to only 4 mA. In this example, the sensor has a 4000 pF load equivalent to 130 feet of 30 pF/foot cable between sensor and signal conditioner. The sensor does not exhibit zero offset with 10 mA supply current (Figure 7b) but does when supply current is 2 mA (Figure 7c).

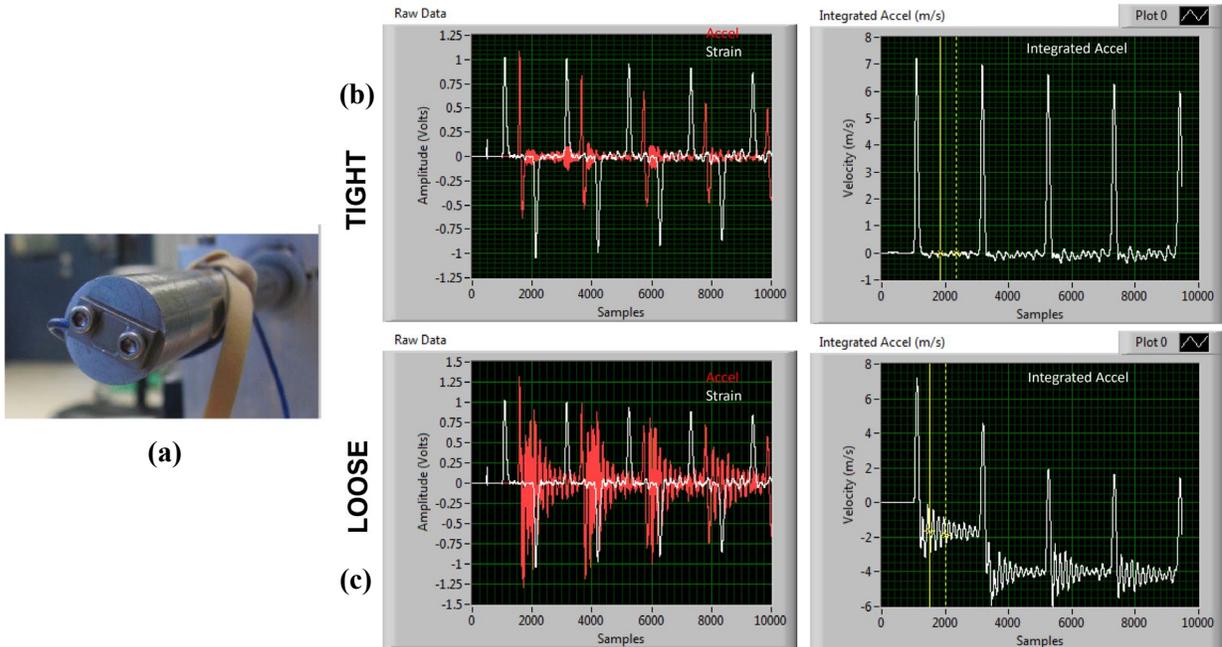
Figure 8. Shock at 50,000G peak with varying mounting torque. PCB Model 3991-60KG PR MEMS sensor mounted to Hopkinson bar (a); integration to velocity with proper mounting torque (b); and integration to velocity with inadequate torque on one of the two screws (c).

The fifth example demonstrates the importance of using the recommended mounting torque (Figures 8 and 9). With proper mounting torque, the sensor does not exhibit zero offset (Figures 8b and 9b). With inadequate mounting torque, the sensor exhibits zero offset (Figures 8c and 9c) as well as ringing (Figure 8c).

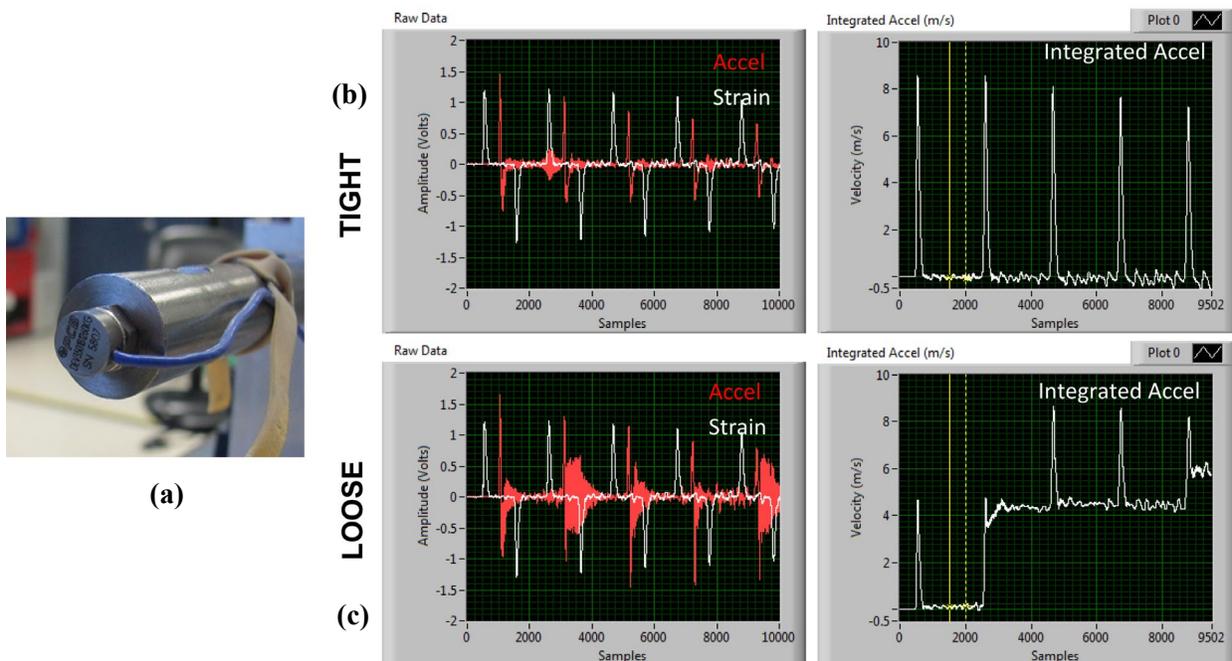
Figure 9. Shock at 50,000G peak with varying mounting torque. PCB Model 3501-50KG PR MEMS sensor mounted to Hopkinson bar (a); integration to velocity with proper mounting torque (b); and integration to velocity with inadequate torque (c).

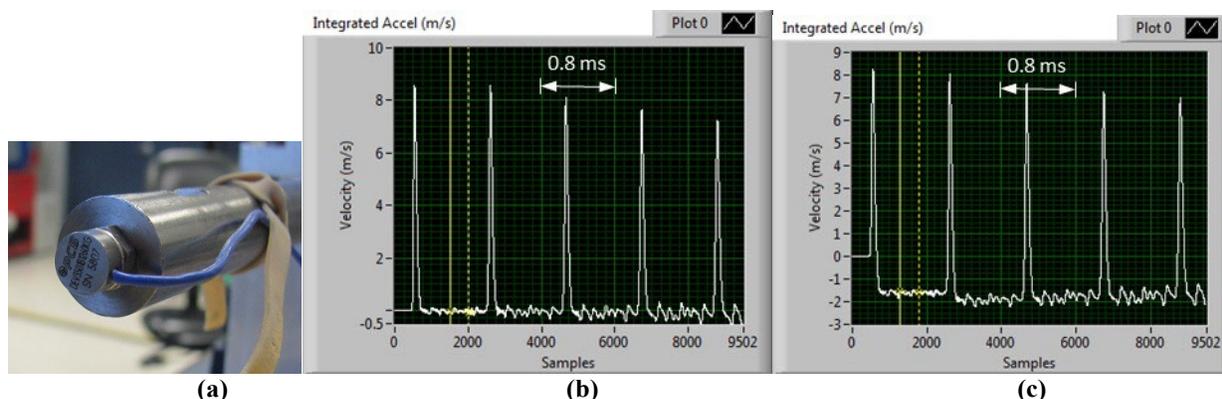
Figure 10. Shock at 60,000G with varying conditioner gain. PCB Model 3501-60KG PR MEMS sensor mounted to Hopkinson bar (a); integration to velocity with adequate ranging of signal conditioner gain (b); integration to velocity with excessive gain causing clipping in signal conditioner (c).

The sixth and last example demonstrates the importance of the signal conditioner with gain properly chosen as to not over range (Figure 10). In this example the signal gain is sufficient to clip the peak accelerometer signal, resulting in zero offset in the velocity record (Figure 10c). Clipping in the signal conditioner is insidious in that the clipping in the accelerometer record may be masked by subsequent low pass filter stages.

Ones sided clipping (as seen in the example in Figure 10) may show more significant errors.

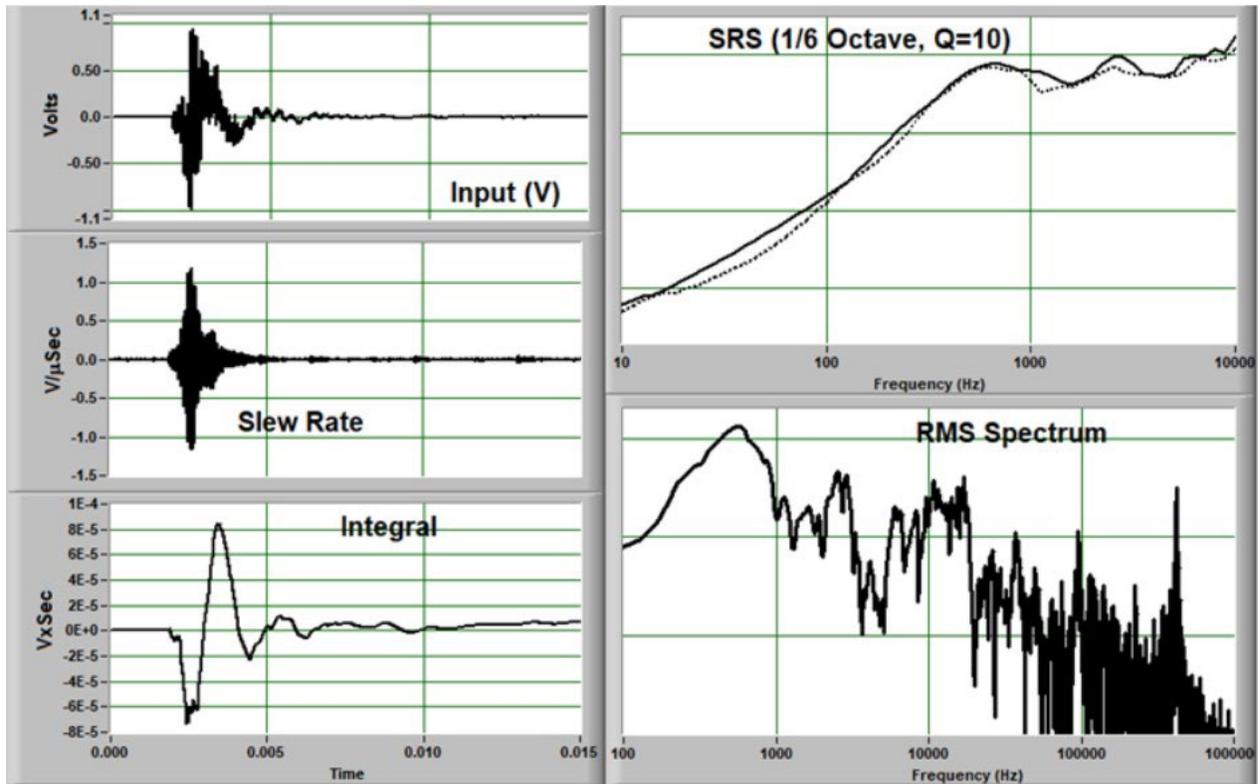
The data from the 7270 will be used to demonstrate the effect of the errors listed above. The voltage response has gain applied to make it's time history peak = 1 volt as shown in Figure 12. Pertinent derived parameters are:

- Upper Left Frame: The voltage output (normalized to 1 V).
- Middle Left Frame: Slew rate in Volts/ $\mu$ Second
- Lower Left Frame: The integral, proportional to velocity, which (correctly) approaches zero after the shock.
- Upper Right Frame: The positive (solid) and negative (dotted) Shock Response Spectrum. The two curves agree well.
- Lower Right Frame: The RMS Spectrum that shows:
  - Significant signal energy out to 700 KHz.
  - The transducer resonance at 415 KHz.

Figure 12. Shock Response Measured with an Endevco 7270  
Scaled to 1 Volt Peak

Slew rate is an increasingly important consideration when using essentially undamped accelerometers with their associated very high resonant frequencies (e.g. Model 7270). A detailed study of the record in Figure 12 was performed by one of the authors (S. Smith) of this paper. It concluded that when applying gain to the 7270 to acquire the equivalent signal levels as the 350DO2 to 10 KHz, the slew rate demands on the signal conditioning channel for the 7270 in this instance were 15 times greater than that required for the 350 DO2.

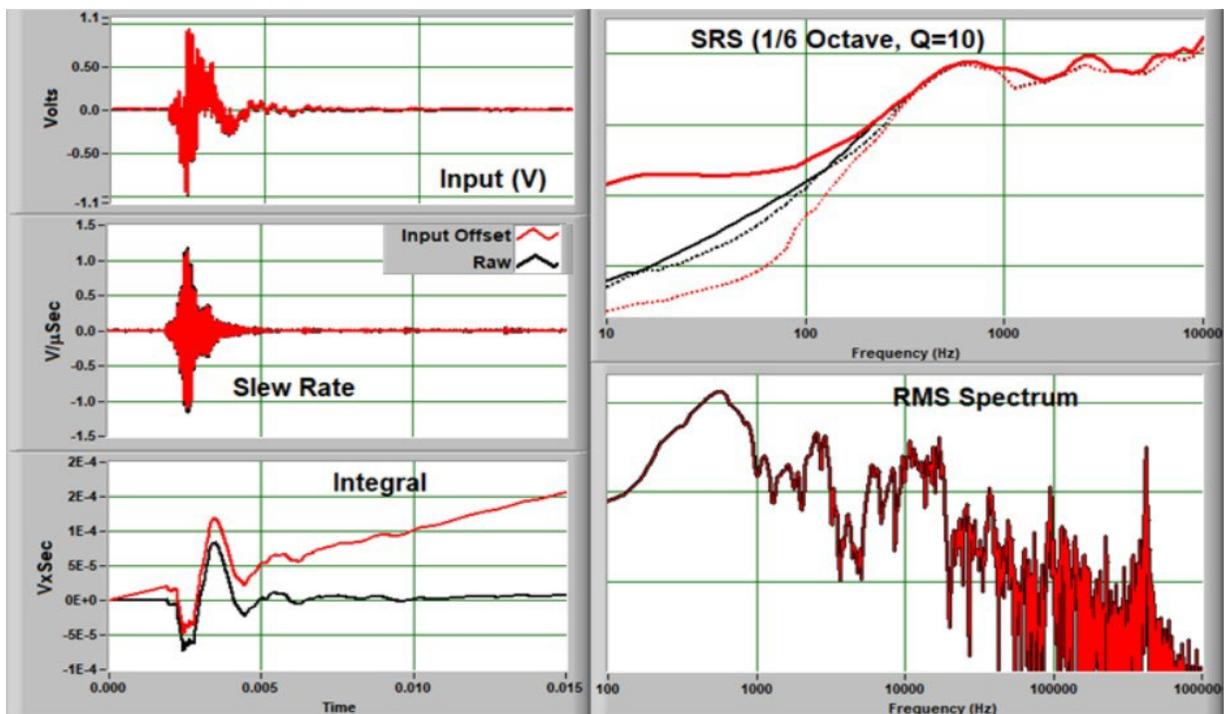
Figure 13 shows the effect of adding an offset of 1% of the peak value to the data. The integral and low-frequency shock response spectrum (RED) are significantly compromised. In Figures 13-16, BLACK represents the original signal (Figure 12).

Figure 13. Effect of 1% Offset

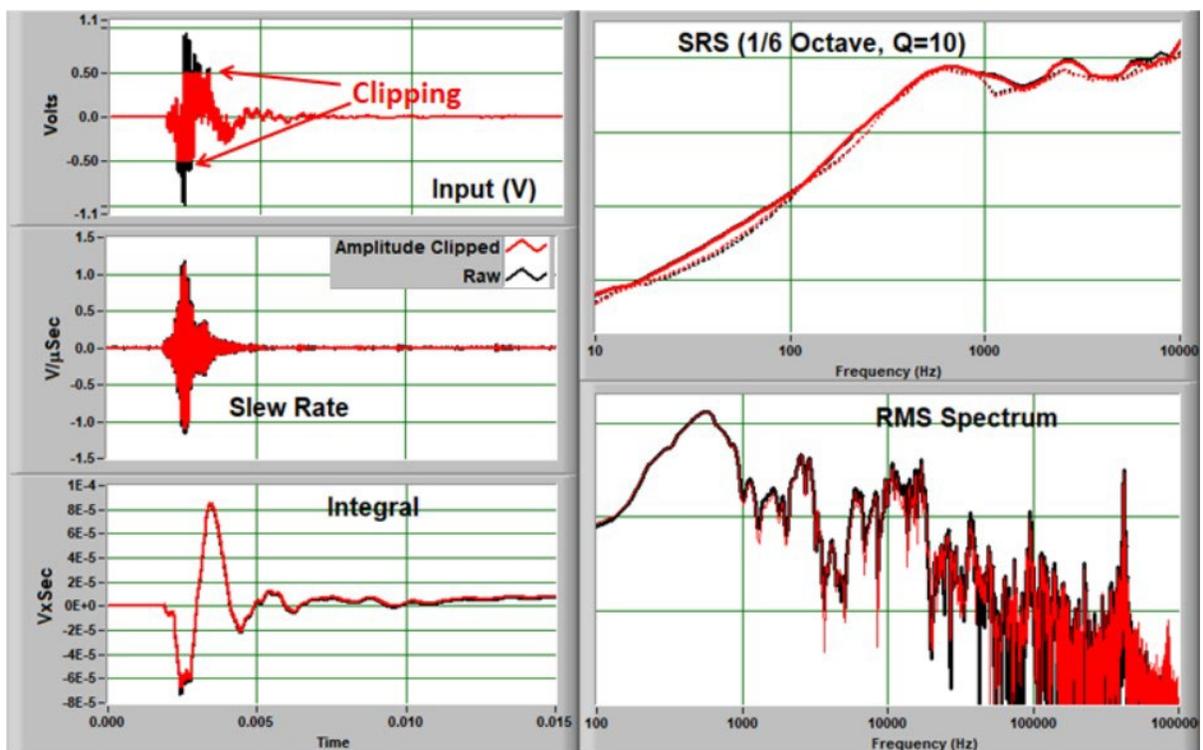
Figure 14. The Effect of 50% Amplitude Clipping

Surprisingly, even drastic clipping, like that shown in Figure 14, does not produce significant offsets (or significant discrepancies in other indications). Only the time record shows the (obvious) error.

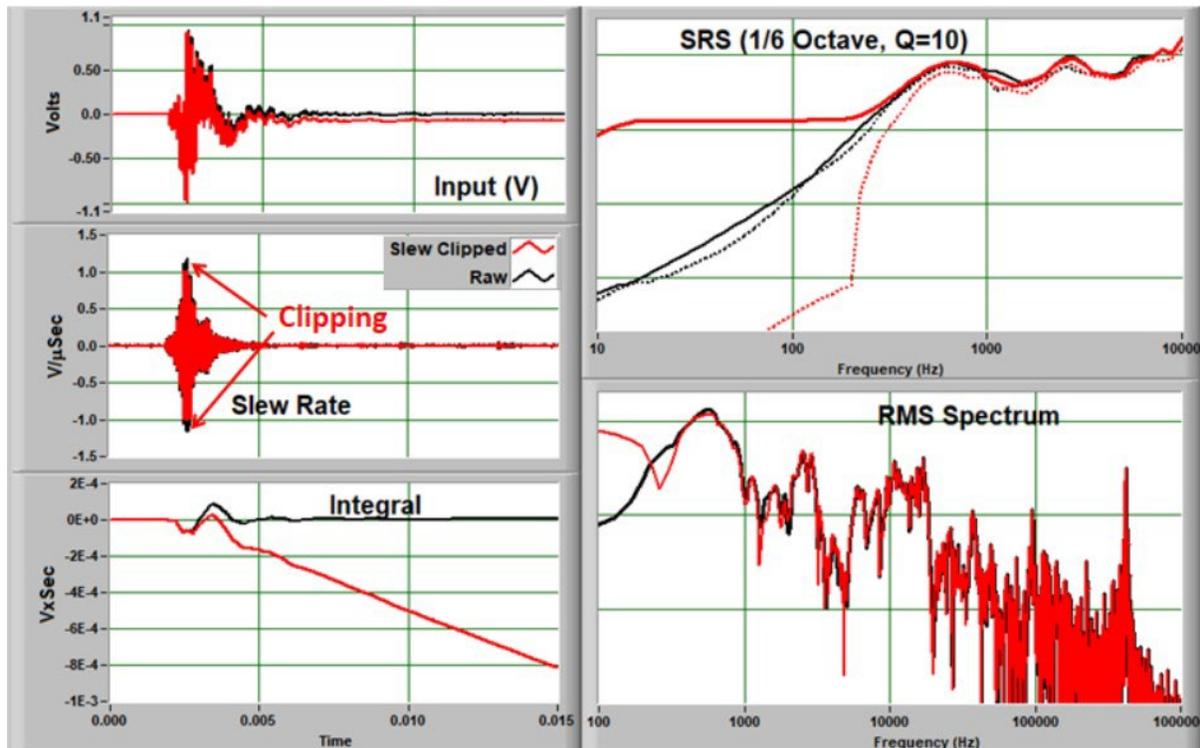
Figure 15. The Effect of Slew-Rate Clipping

Figure 15 shows the effect of a very small clipping on the slew rate. If the amplifier processing this signal is limited to 1 V/μSecond, there are significant offsets. The offset starts at the peak of the slew rate which is also near the peak of the shock. Hence, it looks like an offset error that might be produced by the transducer (discussed above).

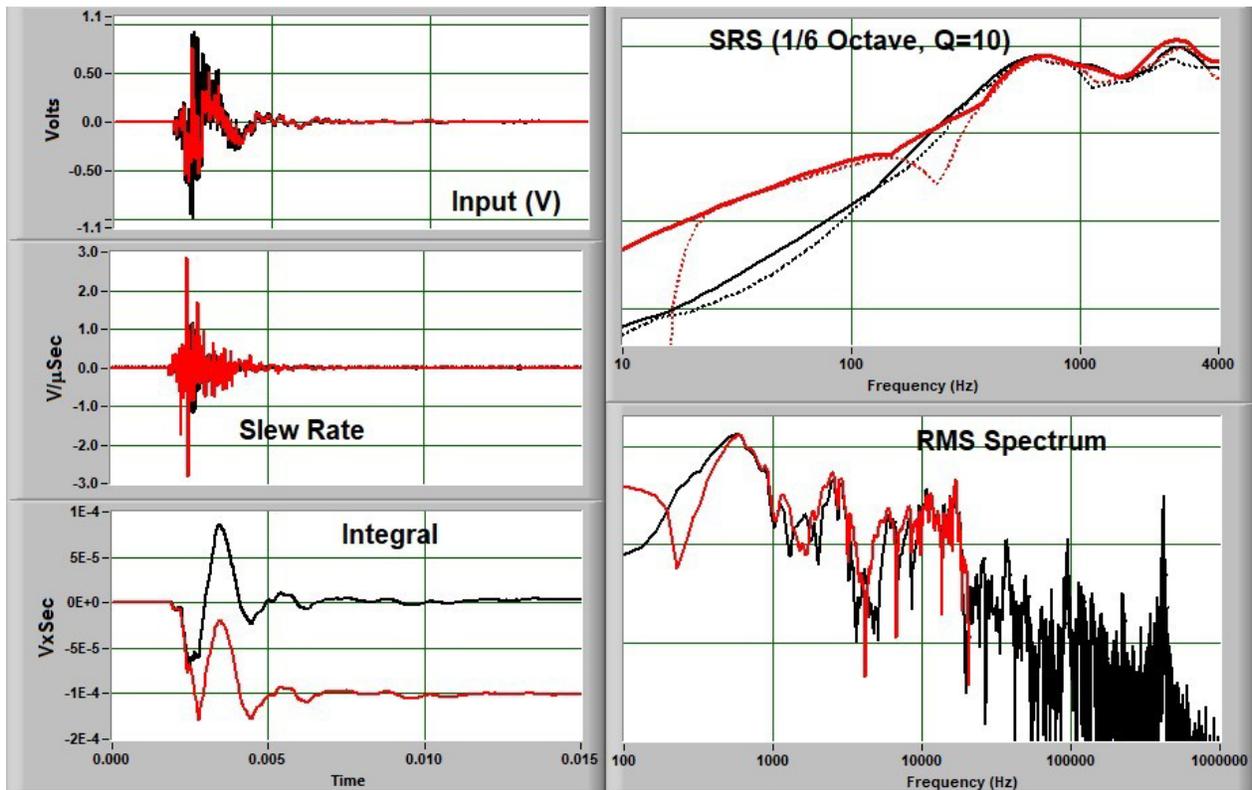
Aliasing errors corrupt the entire frequency range. If energy is aliased to near zero frequency, offsets will occur as shown in Figure 16.

In this case, the sampled signal in Figure 12 has its digitization rate decimated to 40 KS/S without appropriate anti-aliasing filtering. Thus, all the signal energy content above 20 KHz (i.e., the Nyquist frequency) is folded to lower frequencies. Specifically, data frequency content between 20 KHz and 40 KHz is moved to between 0 and 20 KHz, which results in offset components. In fact, this folding occurs multiple times [12].

Figure 16. The Effect of Aliasing
