VIBRATION MONITORING OF GEARBOXES

Written By
James C. Robinson,
Technical Consultant, IMI division of PCB Piezotronics

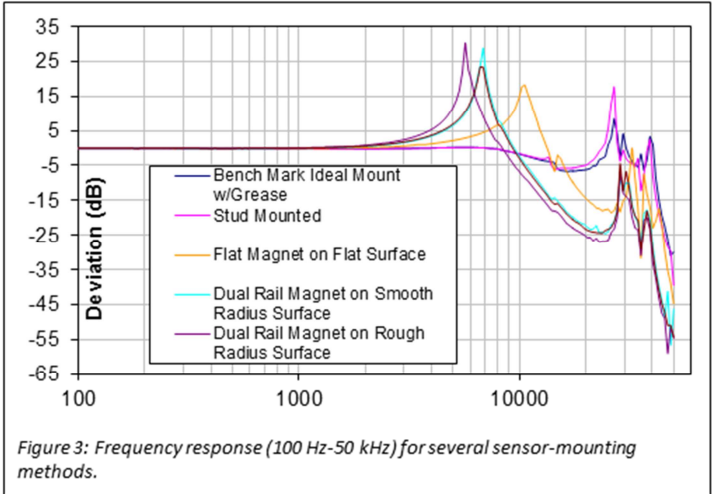
To explore the impact that sensor mounting has on the sensor frequency response, frequency response data was captured (presented in Figure 3) for a sensor that was:

For faults that manifest themselves in the frequency range of less than 2 kHz such as alignment, unbalance and looseness, the results would be independent of how the sensor is mounted. For faults identified with higher frequencies (impacting and friction), the results would be highly dependent to how the sensor is mounted ranging from no response to distorted response.

Of course, the best way to mount would be stud-mount with a specified torque. This could get expensive as it requires a dedicated accelerometer at every measurement point. An acceptable alternative mounting would be to use a flat magnet placed on a flat smooth surface such as a mounting pad. The flat magnet approach to all measurements points combined with stud mounting the sensor in radial direction on the inboard and outboard ends would be a recommended method for sensor mounting.

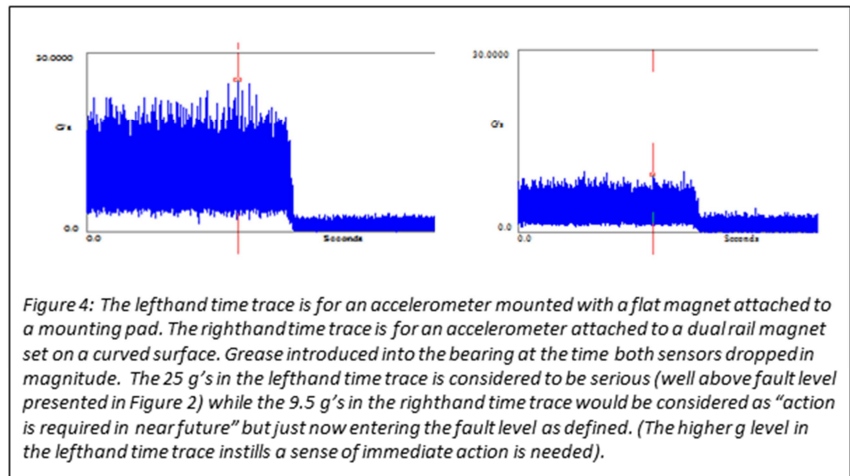
To illustrate the type of effect that sensor mounting can have on friction activity, data is presented in Figure 4 from a case where it was known that bearing lubrication was needed. In the lefthand time trace, the sensor was mounted using a flat magnet attached to a flat smooth surface. A second set of data on the righthand time trace was acquired from a sensor attached to a curved surface via a dual-rail magnet. Both time traces were taken at the same time using a two-channel data collector. The bearing was lubricated (greased) at the time the sudden level of noise decreased.

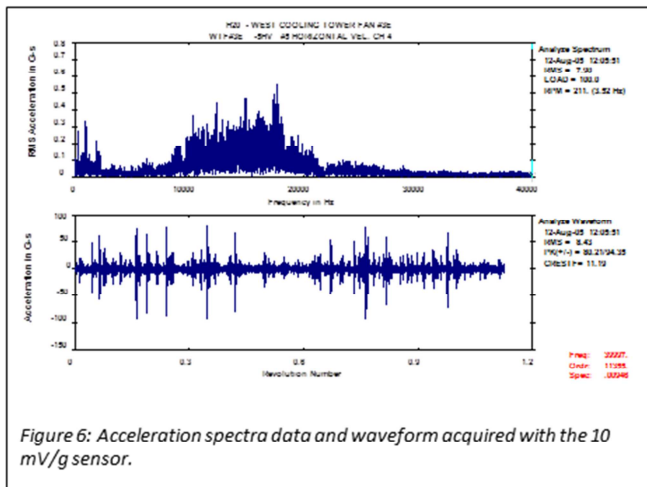
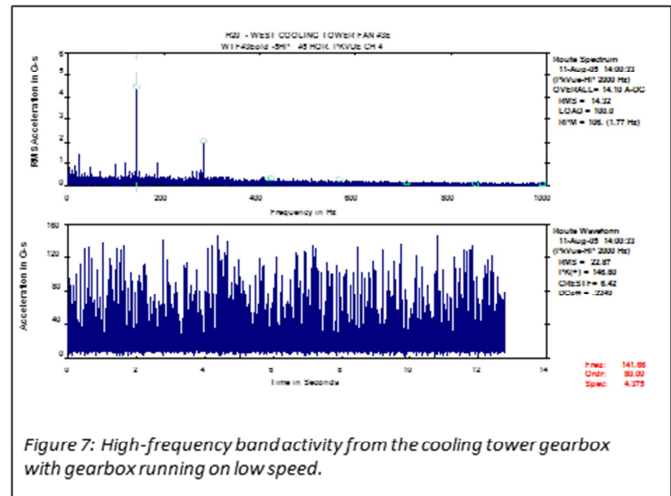
The accelerometer was replaced with a 10 mV/g accelerometer with a similar bias voltage. Using the 10 mV/g sensor, a 40 kHz acceleration spectra data set with waveform was captured and is presented as Figure 6. The peak-to-peak g-level was close to 200 g's, explaining why the 100 mV/g sensor's output was unstable. The primary cause of the high g-levels was friction occurring within the bearings as well as between the gear teeth as a result of an inoperable lubrication system driven by a gear oil pump.

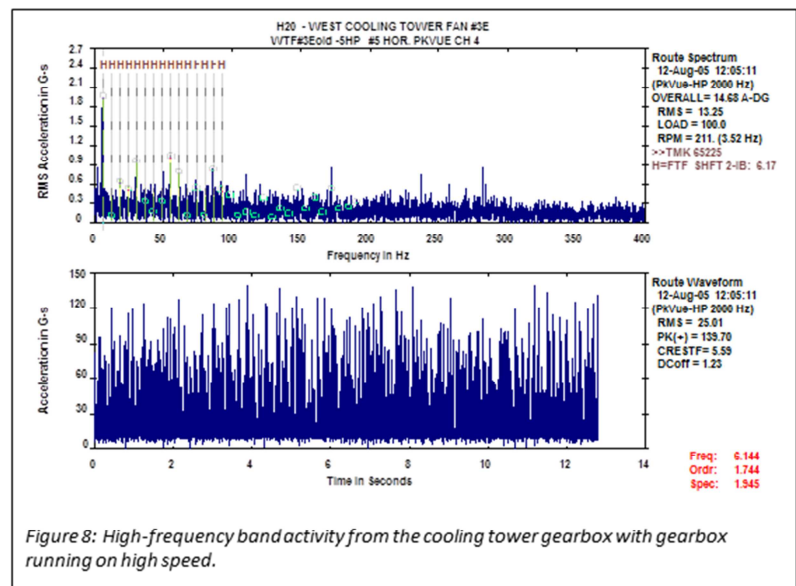
The operators chose to continue operating the cooling tower rather than take the time to correct the lubrication problem. They did ask the analyst if it would be best to run the gearbox at high speed or at low speed. It was decided to run high-frequency analysis at both speeds to see if the best speed could be determined from the data. The high-frequency band chosen for the analysis was 2-40 kHz. The results for the gearbox running at high speed are presented in Figure 7. There was significant periodic activity at one and two times gear mesh frequency. The peak g-level in the waveform is 150 g's, which is very high. The results for the gearbox running at low speed are presented in Figure 8. The significant difference between the high-speed and low-speed activity is the lack of any gear mesh frequency or twice gear mesh frequency activity in the high-speed data relative to the low-speed data. The peak g-level in the high-speed data is 140 g's, which is slightly lower than the peak g-level of 150's in low-speed data. The presence of the gear mesh frequency and twice gear mesh frequency in the low-speed data suggests that debris from the friction between gear teeth was being thrown out into bearings. The conclusion was that there was sufficient oil in the bottom of the gearbox to permit the gear to sling oil out to lubricate the gear teeth when running at high speed. Therefore, it was decided that less damage would occur with the gearbox running at high speed. The gearbox was run at high speed until replaced with the new gearbox.

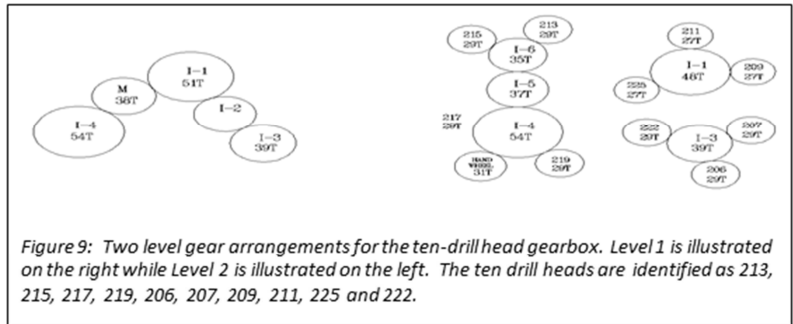
Figure 9: Two level gear arrangements for the ten-drill head gearbox. Level 1 is illustrated on the right while Level 2 is illustrated on the left. The ten drill heads are identified as 213, 215, 217, 219, 206, 207, 209, 211, 225 and 222.

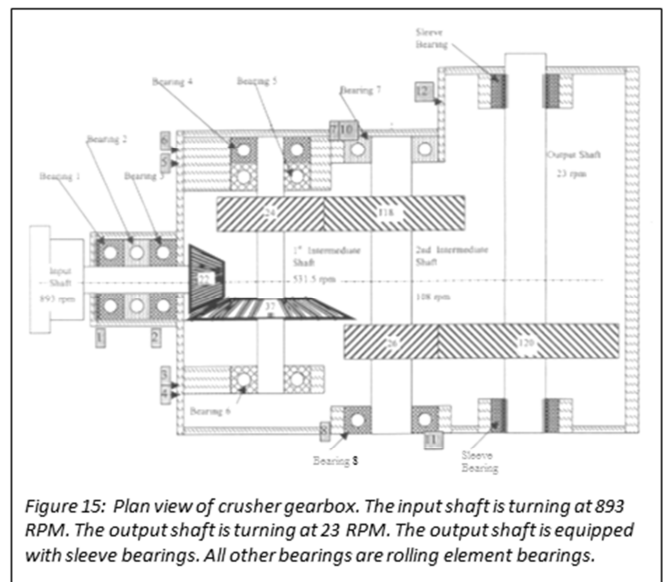
Routine monthly vibration data was acquired from all the measurements points on the gearbox. The high-frequency spectra data and rectified waveform from measurement point #2 are presented in Figure 16. The high-frequency band is from 1 kHz to 40 kHz. The 1 kHz is well above 2.25 times gear mesh frequency. (Gear mesh frequency is 330 Hz, which equals running speed of motor [15 Hz] times the number of teeth [22]). The bearing has an inner race fault in the early stages of failure based on relatively low peak g-level of 3.6 g's. The measurement was repeated approximately one month later and results are presented in Figure 17. The big difference in Figures 16 and 17 is the peak g-level has increased from 3.6 g's to 51 g's, which is significant. This bearing, based on high g-level of 51 g's, requires frequent monitoring with a replacement plan set in motion.

Figure 15: Plan view of crusher gearbox. The input shaft is turning at 893 RPM. The output shaft is turning at 23 RPM. The output shaft is equipped with sleeve bearings. All other bearings are rolling element bearings.

To assure the faulty bearing was bearing #3 and not bearing #1 or bearing #2, data was acquired from measurement point #1 at same time as the data in Figure 17 was acquired. The peak g-level in the high-frequency data from measurement point #1 was 25 g's versus the 54 g's from measurement point #2. The defective bearing was concluded to be bearing #3. Frequent monitoring with the sensor set on measurement point #2 was then carried out. The peak g-level trend is presented in Figure 18. From the time the 50 g peak level was detected, it took about 25 days to get the bearing replaced. A picture of the defective bearing is presented in Figure 19. The peak g-level recorded was about 80 g's.

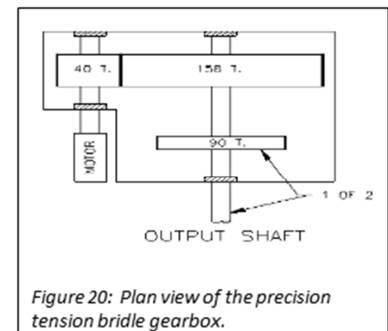
Figure 20: Plan view of the precision tension bridle gearbox.

A plan view of a precision tension bridle gearbox is presented in Figure 20. The gearbox has a single shaft input with a dual shaft output that ultimately drives the work rolls. The low-frequency and high-frequency band spectra and waveform data were taken with sensor placed over bearing at input to gearbox. The low-frequency band data is presented in Figure 21. The input gear mesh frequency (approximately 351 Hz with second harmonic) is being modulated. The lower gear mesh frequency (approximately 202 Hz) for the 90-tooth gear set is sharp (no indication of modulation) and the second harmonic is not discernible. The rectified waveform and spectra data for the high-frequency band of data from 0.5 to 40 kHz are presented in Figure 22.

The spectra data indicates a significant event is occurring once per output shaft revolution. The waveform clearly demonstrates there are two distinct impulses per turn that could mean there are two cracks on one gear. When inspected, two cracked teeth on one gear were found.

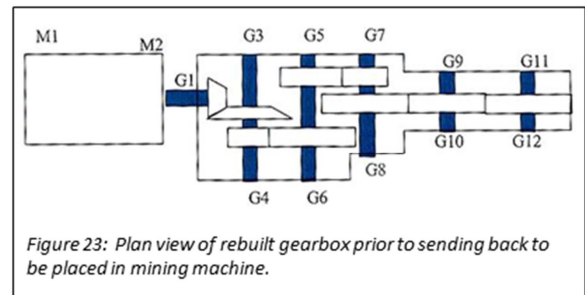
Figure 23: Plan view of rebuilt gearbox prior to sending back to be placed in mining machine.

A gearbox was removed from a mining machine and sent back to the shop for rebuild. A plan view of the gearbox is presented in Figure 23. This gearbox has four gear mesh frequencies. After the rebuild, the machine was subjected to vibration analysis for high and low-frequency bands prior to sending it back to the field. The vibration analyses are carried out on the twelve measurement points (as needed) identified on the gearbox as points G1 through G12. There is a measurement point placed over each bearing. In this case, focus is directed to the low-frequency band up to 1.5 kHz and the high-frequency band from 1 kHz to 40 kHz data from measurement point G5.

The waveform and spectra data for the low-frequency band are presented in Figure 24. The peak-to-peak g-level in the waveform data is about 1.1g's, which is not considered to be indicative of a problem. The high-frequency band rectified waveform and spectra data are presented in Figure 25. There is a spike (about 14 g's) occurring once per revolution of the shaft immediately below measurement points G5 and G6. This is the expected signature from a cracked tooth in the gear immediately below measurement point G5. Upon inspection of this gear, it was found to have a crack in the root.
