Smart Technologies for Predicting Catastrophic Machine Failures

ABSTRACT

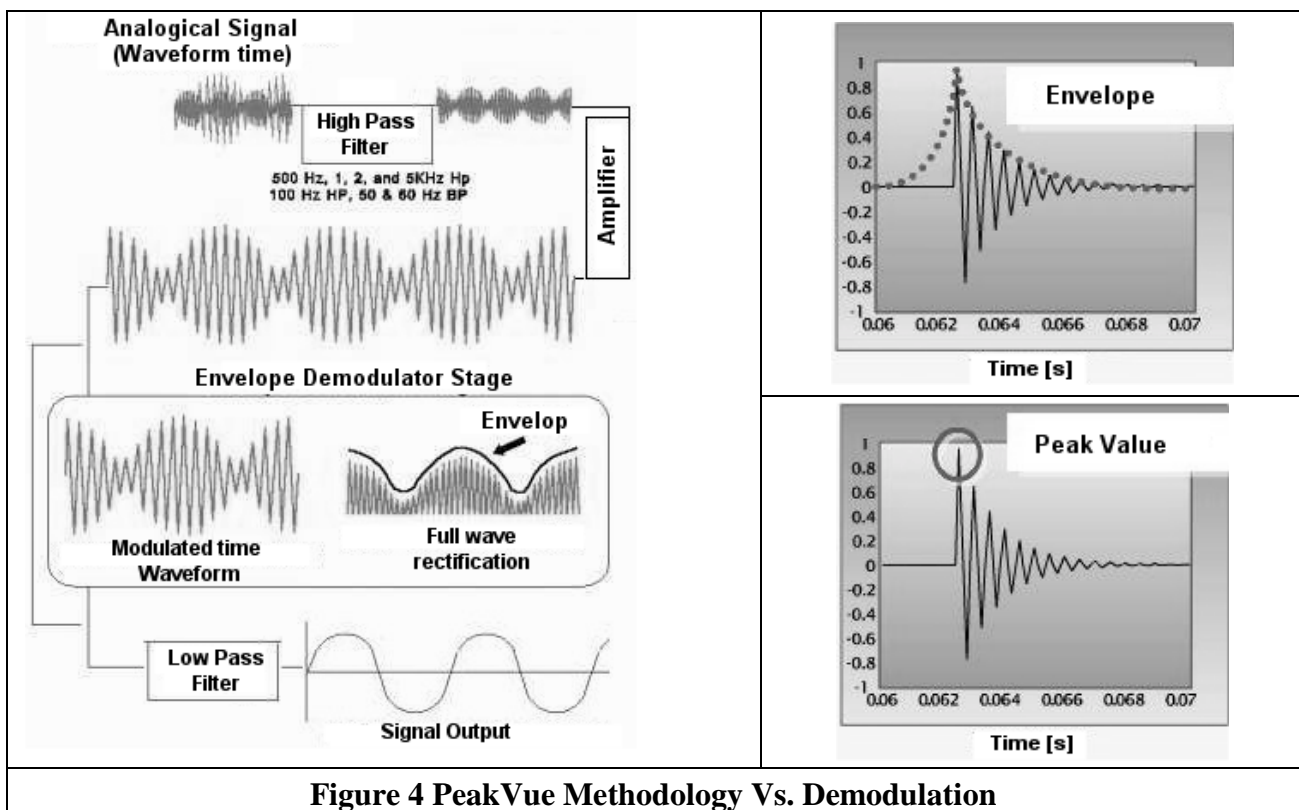
Figure 4 PeakVue Methodology Vs. Demodulation

PeakVue detects the presence of the stress waves mainly due to metal to metal contact during an early stage of the failure. Like the demodulation, this technique isolates the resonance zones by means of high pass or band pass digital filters, but it is differentiated from the demodulation

technique in that in the final stage the enveloped detector is not used, rather using a high frequency sampling (100 kHz) catches the peak value for each interval of the normal sampling time. Please refer to Figure 4.

PeakVue is does not use demodulation as Demodulation uses a low pass filter where as PeakVue does not. Demodulation measures an average value – PeakVue measures the Peak value. Demodulation detects impact frequency – PeakVue detects impact frequency AND amplitude.

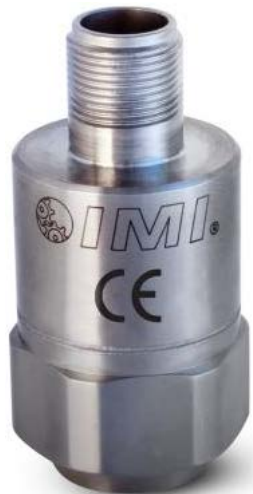
Figure 8. Bearing Fault Detector PLUS (BFD as a USB programmable Accelerometer)

The peak g-level (observed over 6+ revolutions) is the parameter used to identify the presence of fault and establish the severity of the fault. The output of the BFD provides the ability to monitor/trend the peak g-level on a 24/7 basis. When a fault appears and progressively increases in severity, the peak g-level will correspondingly trend upward. Experience from PeakVue enables the ability to establish generic alert and alarm levels (based on the speed of the machine), which can be used as guidelines. This is already discussed in the previous section. BFD PLUS, shown in Figure 8, is a variation of BFD, which is a USB Programmable loop powered device with 4-20mA output, all contained in typical vibration sensor housing.

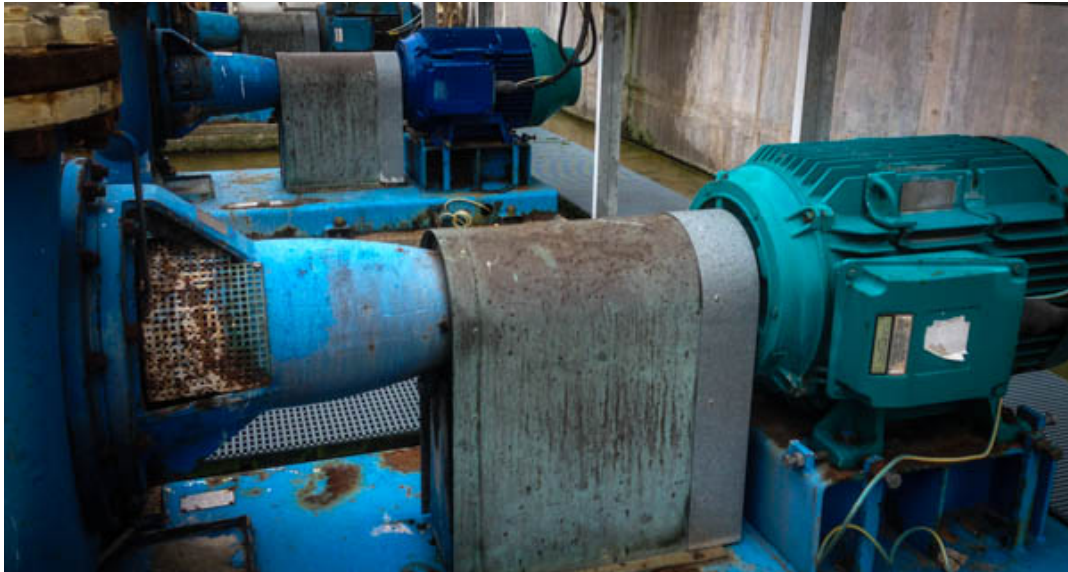
Figure 10 Cooling Water Pump

A Cooling Water Pump (Figure 10) supplies water to process from cooling tower. The failure to supply process cooling water may result in plant shut down within an hour. Normal repair time is around 4hrs from isolation.

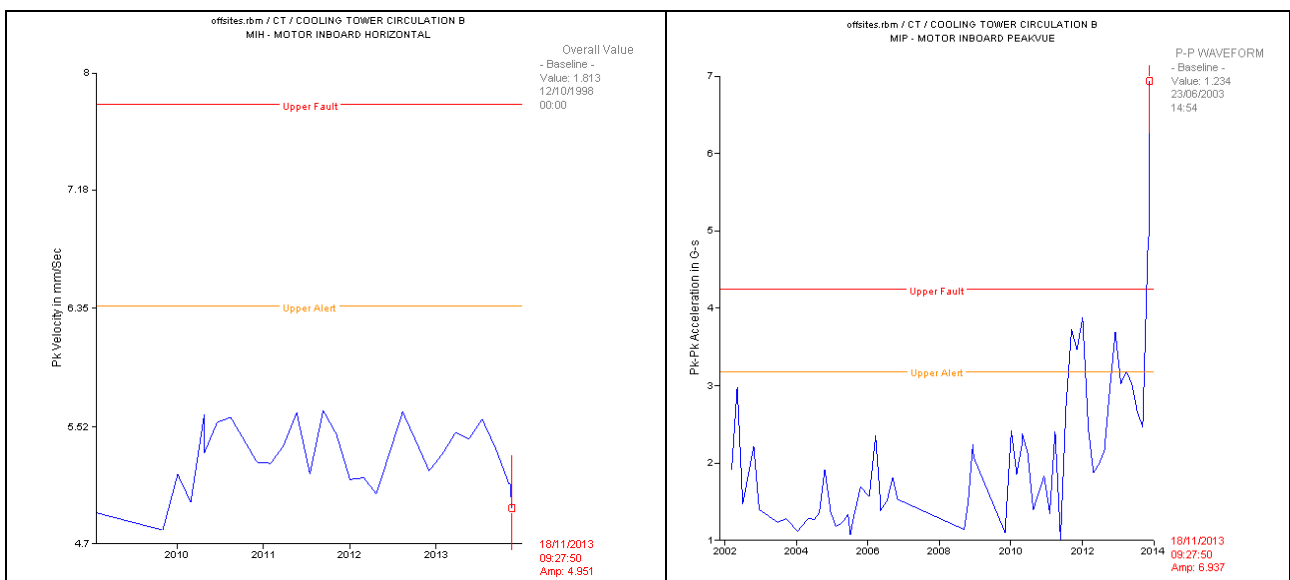
Part of a trio of pumps for redundancy, stand by unit not been run in 18months, when operations tried to put a start on unit failed to start. One week of investigation found the unit was rotating opposite to run direction. Unit had been under review due to steady increase in bearing distress, Step change was detected in Nov13 in PeakVue (Figure 11) with the data indicating bearing failure imminent.

Fig. 11 (a) Baseline Data showing normal trend

Fig. 11 (b) Step change in PeakVue showing the fault

Motor stripped and drive end bearing found to be defective and motor overhauled and returned to standby duty.

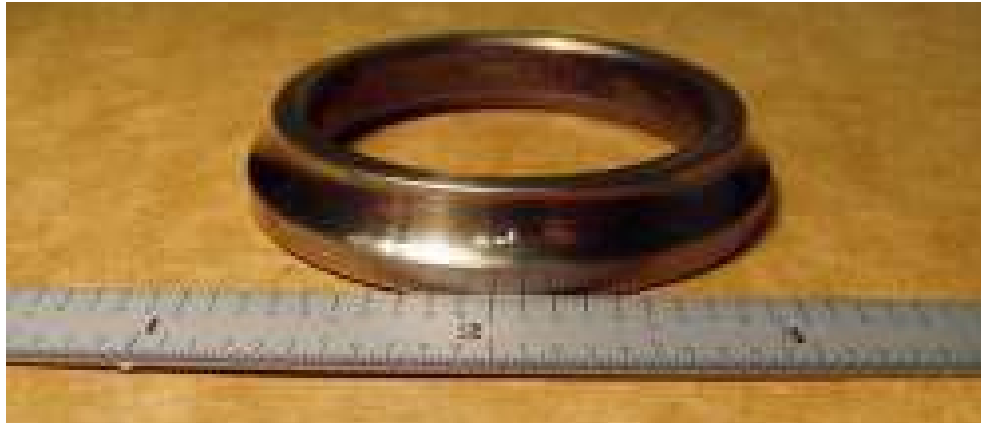
Figure 13 Spalled Bearing of the Pinion Stand Gearbox detected by BFD

Subsequent visual evaluation indicated that, at this point, a 0.1 inch (Figure 13) spall had formed on the outer race. However, the progression of bearing wear to this fault initiation is indicated only by the true peak acceleration data. In fact, this progression was identified at least 3 months before the fault initiated. Since this is an accelerated life test, the time period would be greatly increased in a real world loading situation. In fact, the data indicated that this bearing should be watched carefully as early as three months before the fault initiation as identified by the two peaks.
